# **Watson's Flowers**

**A Building Condition and  
Needs Assessment of**

# Watson's Flowers

Project No. 23-012  
December 20, 2023

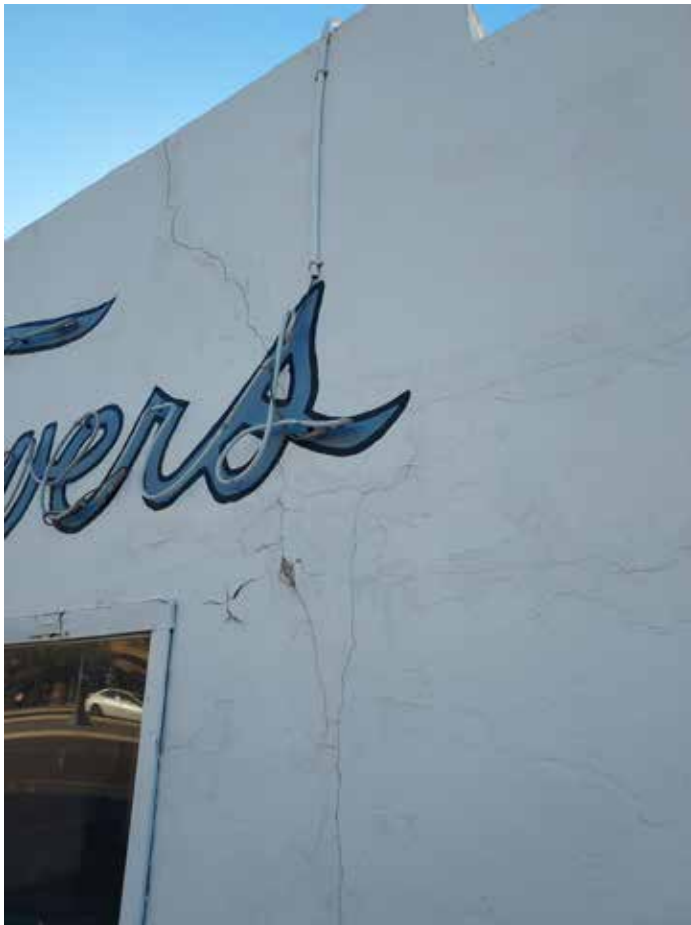
Only one potential settlement crack was observed, on the north side of the building near the northwest corner. The above-grade crack width is not much more than hairline. This could indicate some very minor settlement of this corner.

Hairline cracking is evident throughout the exterior concrete block walls. Because reinforcing is probably minimal, and the walls were constructed without construction joints to allow for thermal movements, this type of cracking is not unusual and is not considered to be a significant defect. One significant movement crack was noted, three feet east of the northwest building corner, vertically through the height of the wall.

*Crack at north wall*

Unless settlement cracking worsens, the foundations are thought to be stable at this time. Monitor the wall crack seasonally to ensure it is not continuing to move. If no movement is noted in 8 to 12 months, no work is necessary.

The movement crack near the northwest corner should be monitored for at least one seasonal cycle by installing a crack monitor. If no movement is noted, no work is necessary. If the crack opens up, additional analysis is warranted.

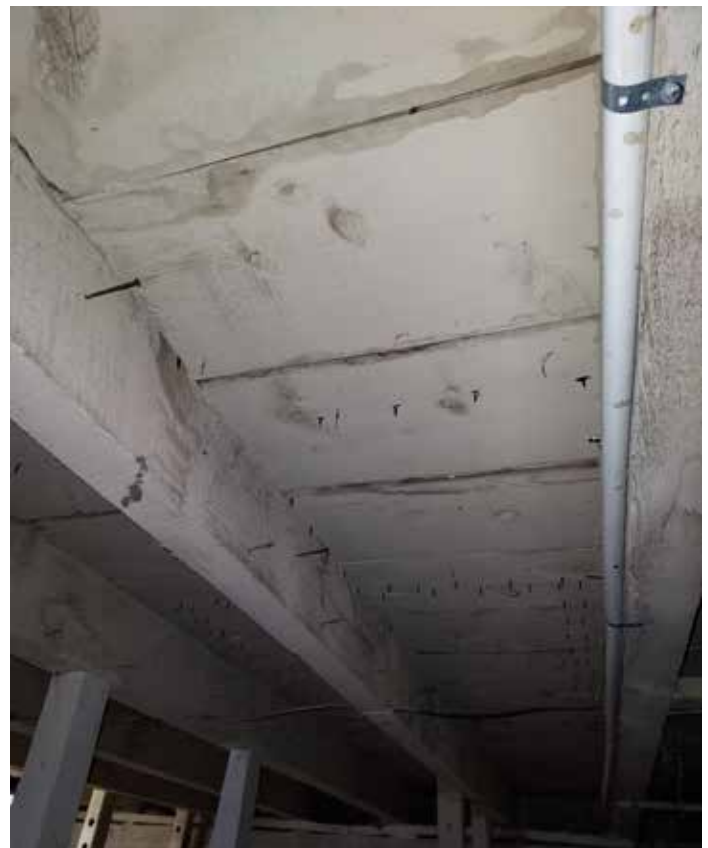
Some of the decking above the basement is severely deteriorated along the west wall, where refrigerated cases were installed for many years. Moisture collecting under the coolers has caused the floor and subfloor to rot.

*Floor over basement*

Rotted decking above the basement should be replaced. The condition of the joists should be verified once the damaged decking has been removed.

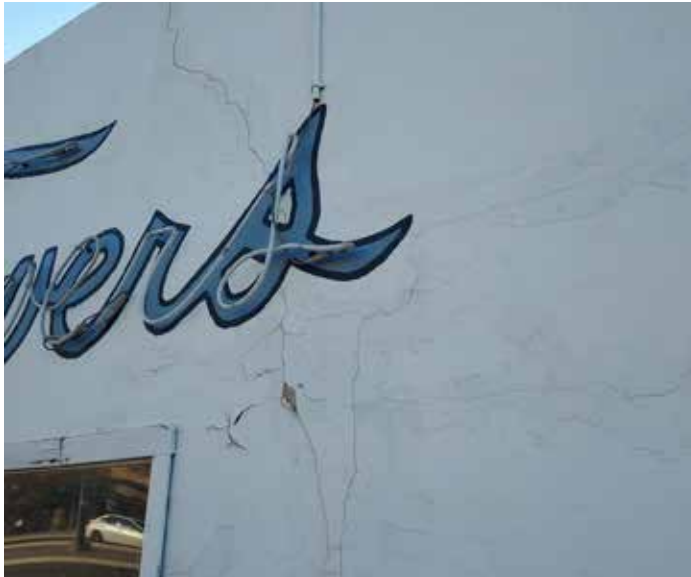
In a few places, the paint on the façade has begun to flake off, revealing a thickness approaching 1/16". The wall crack at the northwest corner is noticeable and admits moisture.

Crack at north wall

Loose/flaking paint should be scraped and leveled and the exterior should be re-painted. As part of the process, the smoothness of the old plaster patches might be addressed, by grinding/sanding. If spidering

of hairline cracks is found to be objectionable, an elastomeric paint may be considered.

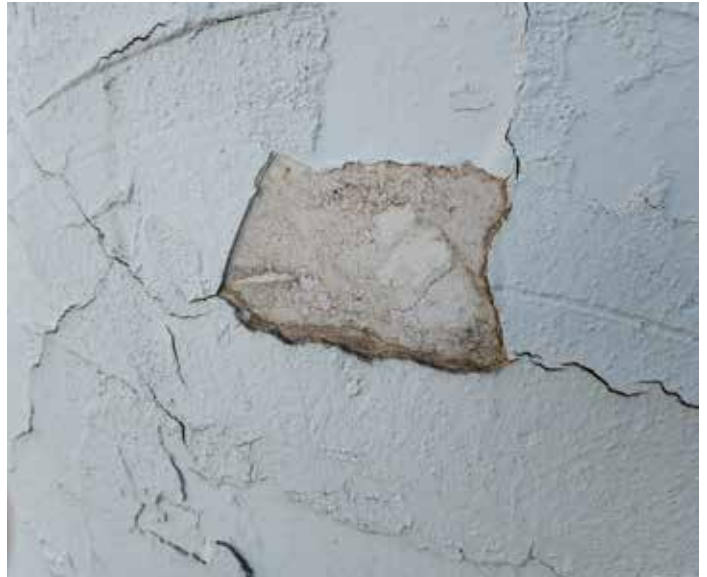
Cracking paint buildup close-up

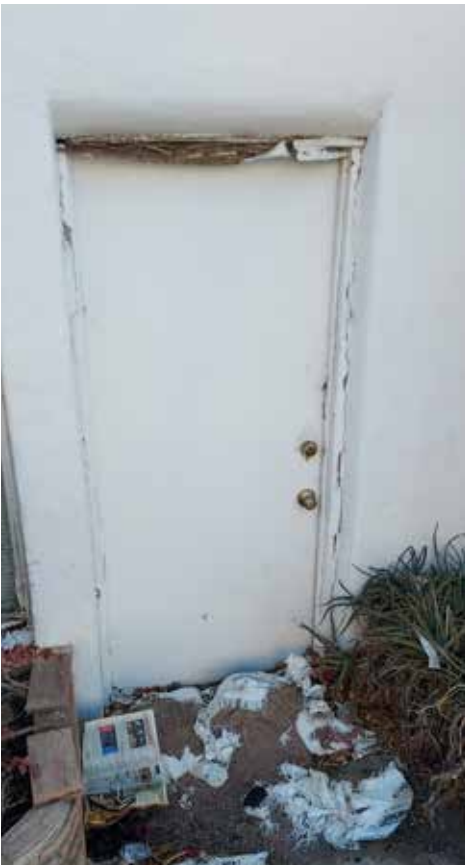
DOOR #	DESCRIPTION	DEFICIENCIES	RECOMMENDATIONS
D01	2'-10" x 6'-8" Solid core flush wood door in wood frame. Has salvaged ball tip half-surface hinges	Frame severely rotted; door is a modern replacement	Replace door and frame with appropriate style; suggest half-glass wood door, using 1930s photo as a guide.
D02	3'-0" x 7'-0" narrow stile aluminum storefront door with 2' sidelight; single-glazed; 1970s-era opening	Fair condition overall, lock broken	The door may be repaired or replaced in-kind, or it may be abandoned and infilled to eliminate it entirely.
D03	Plastered opening 3'-1" x 6'-5", that once was an exterior door to the basement.	Door and frame have been removed. Height of opening is fairly low for a door.	If the door becomes an exterior opening, a door and frame should be reinstalled to protect the basement.
D04	Wooden door frame 4'-6" x 6'-8". Frame has a rabbet on each side to potentially receive a door.	Doors originally opened inward but have been removed. Frame in good condition.	If the door becomes an exterior opening, doors should be re-installed in the existing frame.

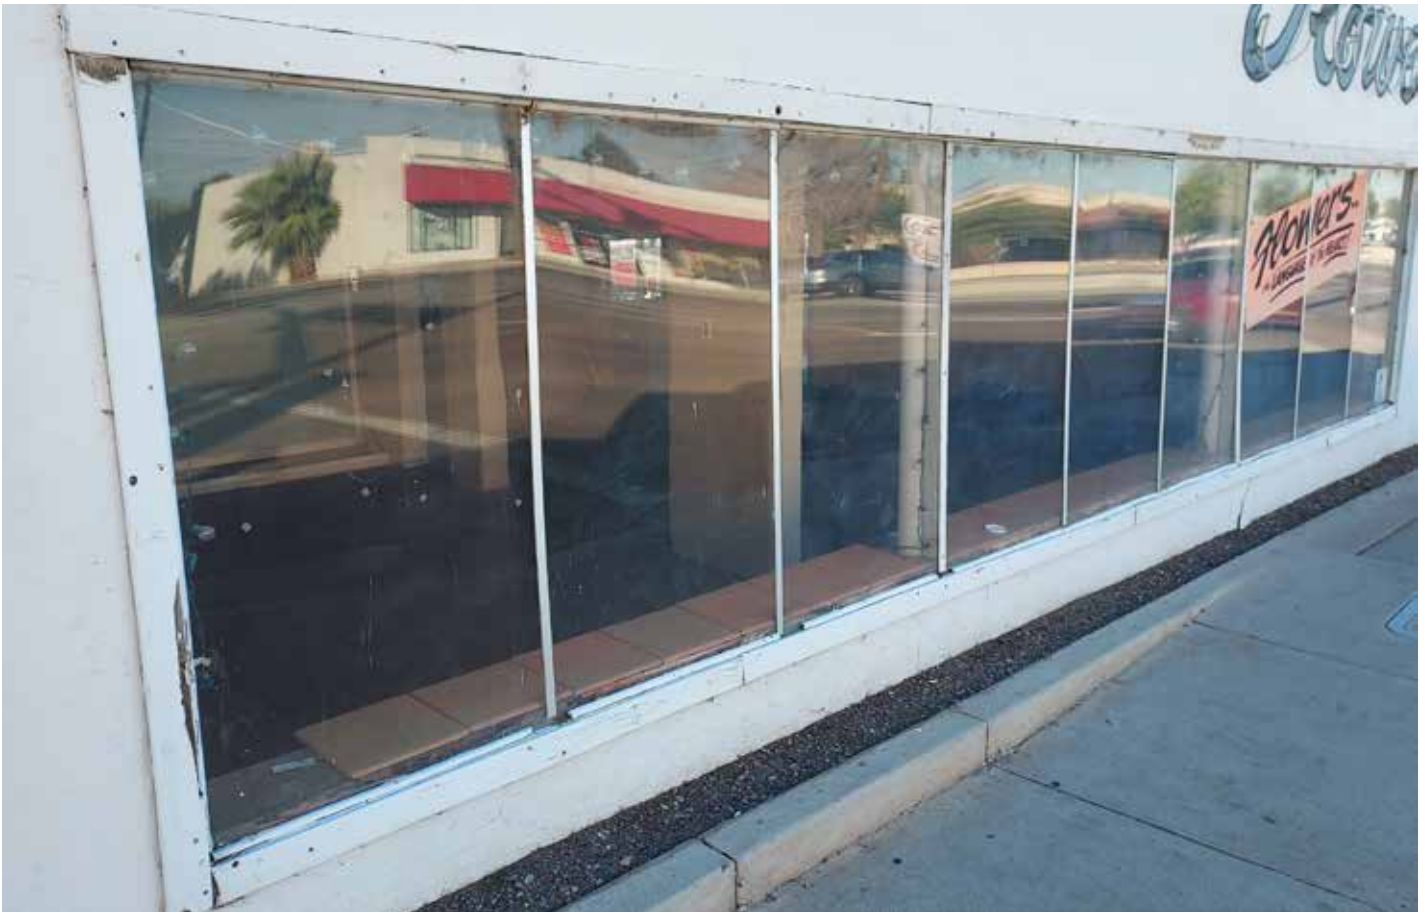
W07	Fixed wood ribbon, 25'-0" x 5'-0" glazed with 9 pieces acrylic glazing joined by aluminum clips	Wood frame and casing deteriorating. Glass replaced with plastic glazing in smaller lights (formerly was 6 panes)	While some of the frame might be useable, all of the casings and glazing should be replaced to match historic photos. Insulated glazing may be used as replacement, with appropriate mounting system.
W08	Steel casement, 1'-8" x 2'-4"	Good condition, but blanked off on interior side.	Maintain and preserve (Low priority)
W09	Steel casement, 3'-4" x 2'-4"	Good condition, but blanked off on interior side.	Maintain and preserve (Low priority)
W10	Aluminum sliding, 4'-8" x 4'-4"	Good condition, nearly new replacement	Preserve, or restore to steel casement (Low priority)
W11	Aluminum sliding, 4'-8" x 4'-4"	Good condition, nearly new replacement	Preserve, or restore to steel casement (Low priority)

W07 Casing and joint view

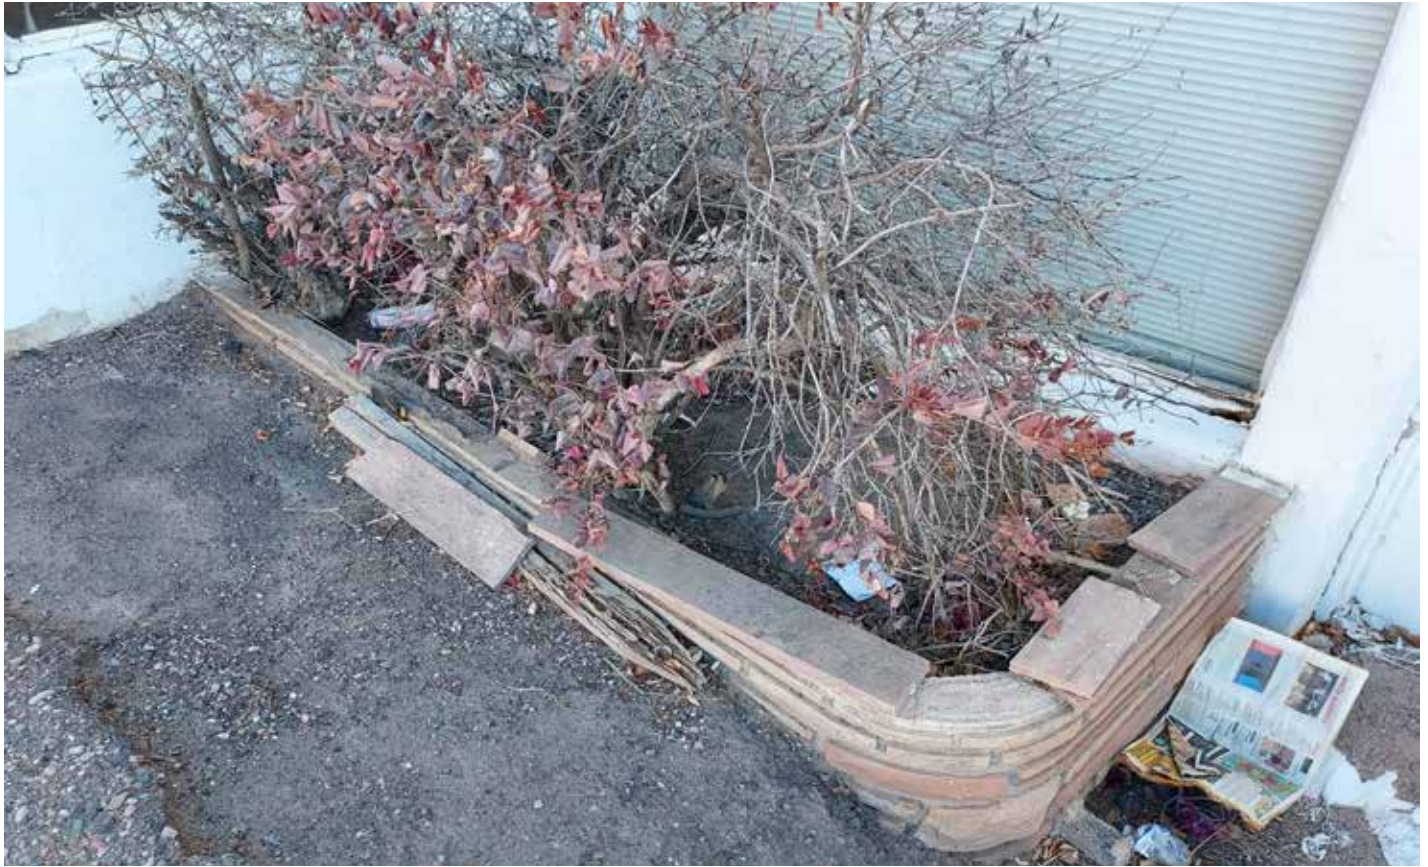
*East planter*

The planters appear to be original and should be preserved. See also the section on Grading and Drainage. The change in level from the sidewalk to the entry door needs to have a better transition, and the backfill should be removed from the planters. Repair of the planters will likely only require re-setting a few stones and fitting a few replacements where the originals have been lost. The soil within the planters should be removed and the interior should be waterproofed before re-filling and re-planting with suitable plants that will not overgrow the space, such as small shrubs and/or flowers.

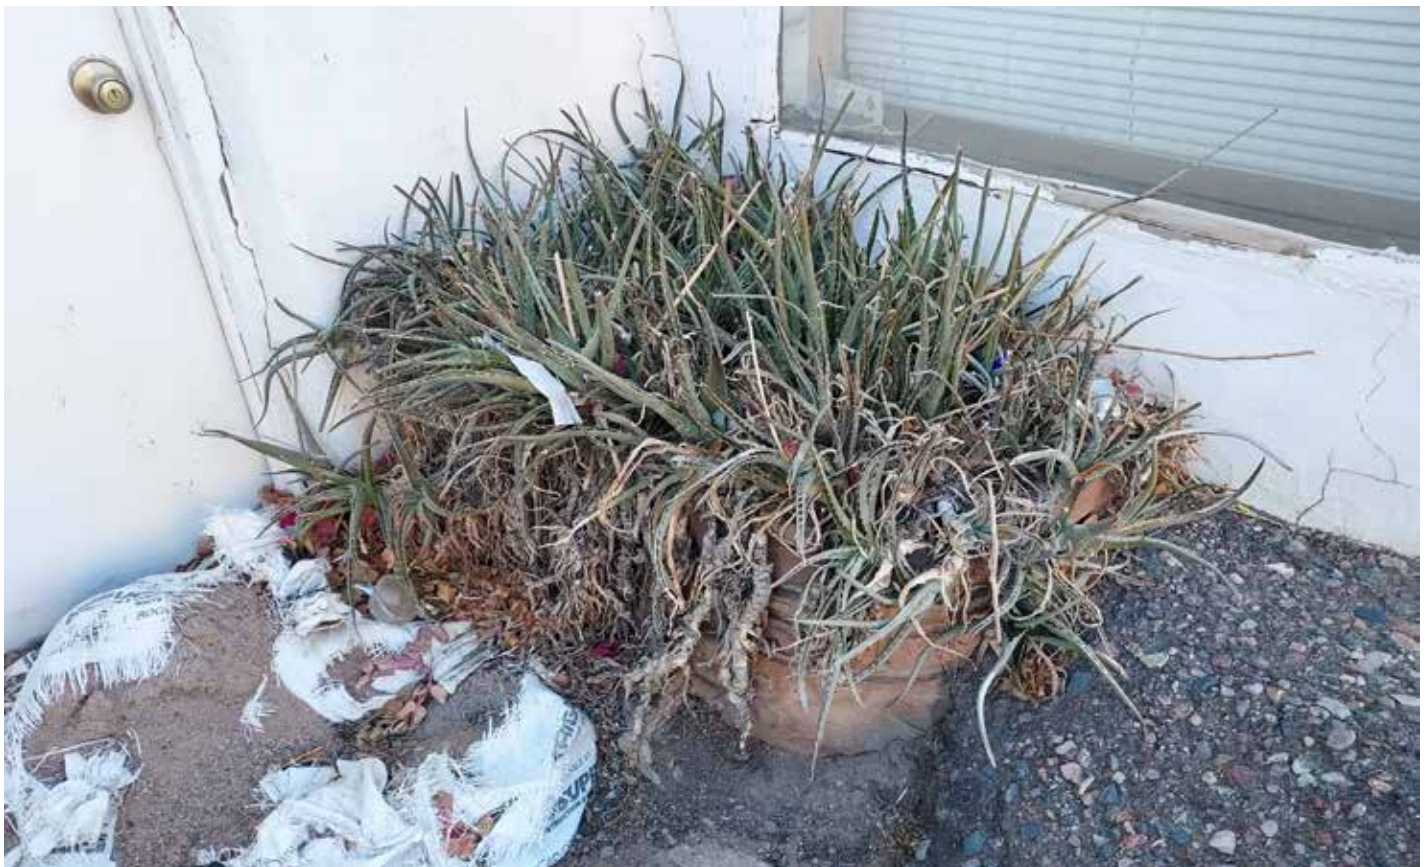
*West planter*
