**CITY OF TEMPE
HISTORIC PRESERVATION COMMISSION**

Subject: Agenda Item #5: Update on the recent graffiti remediation at the Hayden Flour Mill Complex

A Historic Preservation Treatment Plan for Graffiti Abatement of the Hayden Flour Mill Complex, Tempe, Arizona

Results of Graffiti Abatement at the Hayden Flour Mill Complex, Tempe, Arizona

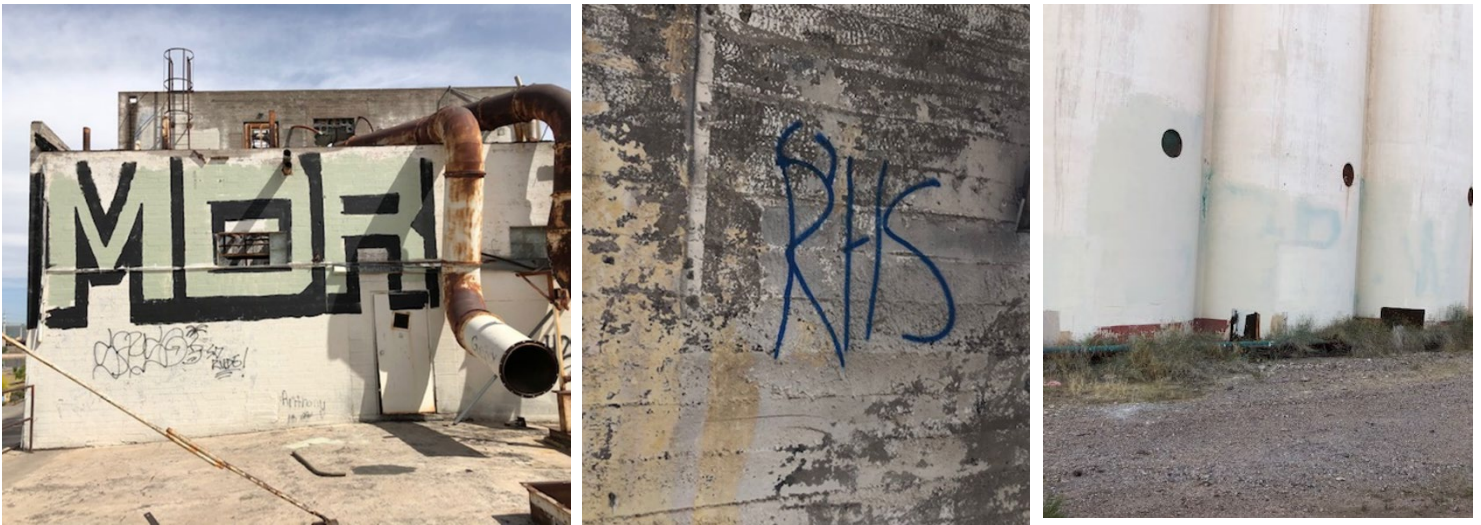
Per the scope of work, the exterior walls of the building and silos are in need of graffiti abatement. Presently, the exterior of the Hayden Flour Mill complex has areas where the buildings have been painted with acrylic-based paint, graffiti and over spray, and areas which have previously been painted over to cover the graffiti, without being sensitive to the historical paint color and sheen (Figure 7). The color and sheen of the building has been extrapolated from historic images and existing conditions, which suggest that over time it has exhibited a matte finish and was generally of an off-white color with sections of red or brown paint along the foundation.

Figure 7. Examples of typical exterior paint and graffiti at the mill, including areas which have been vandalized and subsequently painted as an abatement strategy (Logan Simpson 2021).

The overall preservation plan consists of exterior graffiti abatement to the mill and silos, followed by repainting, where needed, using paint that matches the historic colors and sheen. The abatement will be completed in two phases as outlined below:

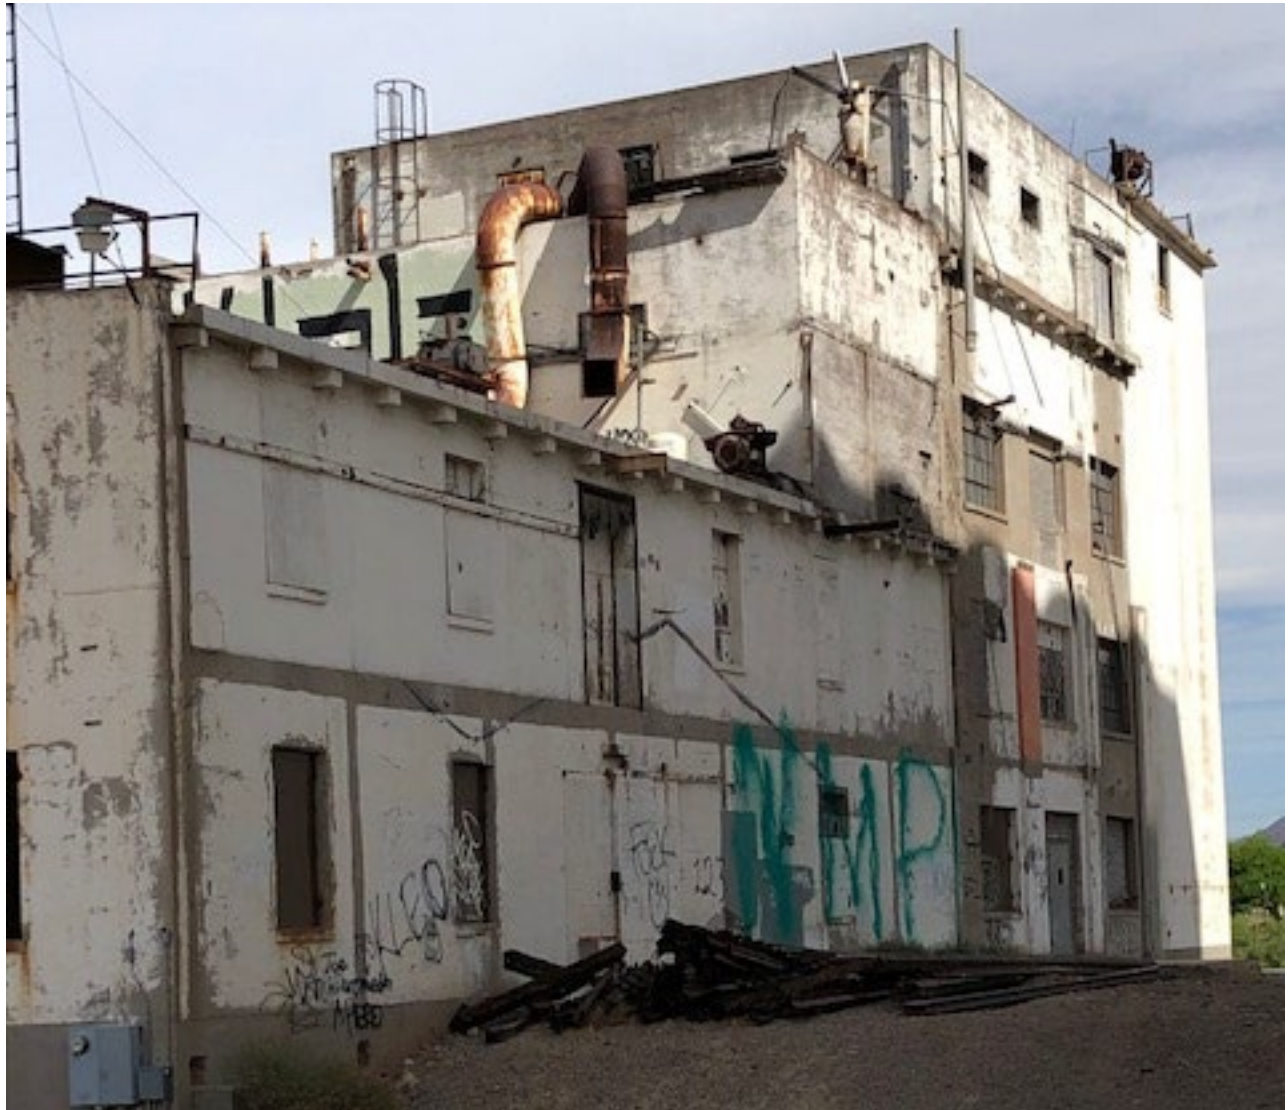
The abatement areas are divided into three locations. Abatement Area 1 is defined by the east elevation of the mill where 11 occurrences of graffiti range in size from 2 feet to 360 sq feet. The graffiti in this area is located on painted concrete surfaces, concrete masonry units, and steel doors. The locations of these areas also vary in height and extend up to 18 feet tall. Where applicable, scaffolding or an articulated lift will be used to access these locations. Abatement Area 2 includes the rooftop of the mill where at least four occurrences of acrylic-based paint or indelible marker graffiti ranging in size from 2 square feet to 400 square feet exist. The maximum elevation for this abatement area is 16 feet. Abatement Area 3 is comprised largely of the the west, north, and south elevations of the silos, where graffiti has been previously painted over in at least three locations with an acrylic-based paint on concrete walls and steel doors. The graffiti extends up to 16 feet high in this area. Where applicable, scaffolding or an articulated lift will be used to access these locations.

Figure 2. Photograph of exterior graffiti on the east elevation of the mill complex (Area 1). Photograph taken on April 16, 2021, facing northwest.

CCP completed Phase I of the graffiti abatement between May 23 and May 31, 2022, using the Taginator and Tagaway chemical treatments, a mobile power washing unit, and water truck. Scaffolding and an articulated lift were set up prior to starting the abatement work to allow safe access to graffiti tags at higher elevations on the exterior walls. Taginator and Tagaway were used in conjunction with one another since they are designed to work on different types of surfaces. Both products are fast acting, free rinsing, and biodegradable (see Cottrell-Crawford et al. 2022). The abatement methods generally involve applying the Taginator/Tagaway products, as appropriate, and then rinsing the surface with low pressure water (warm to hot temperature).

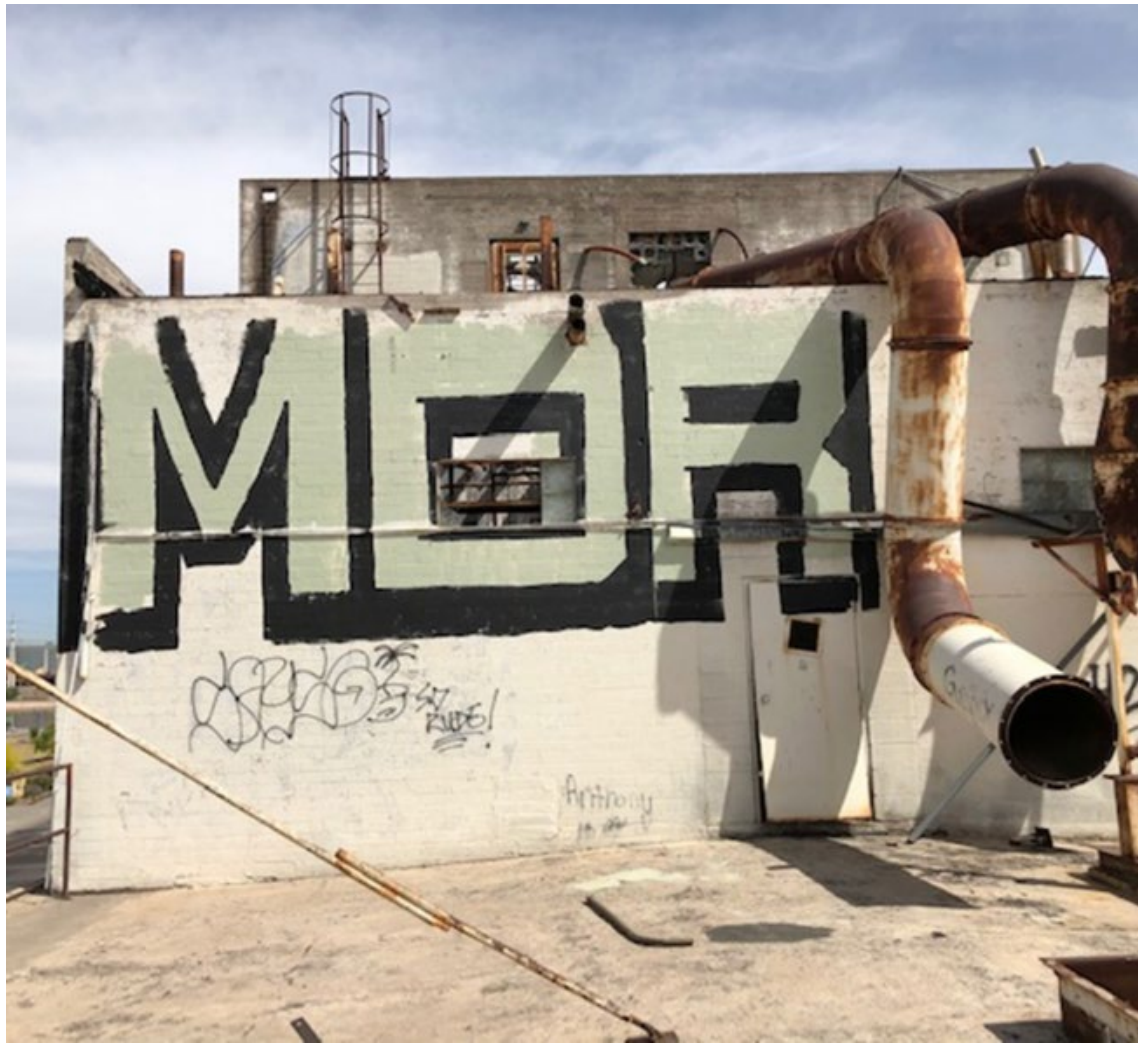
Figure 3. Photograph of exterior graffiti on the south-facing roof area the mill complex (Area 2). Photograph taken on April 16, 2021, facing north.

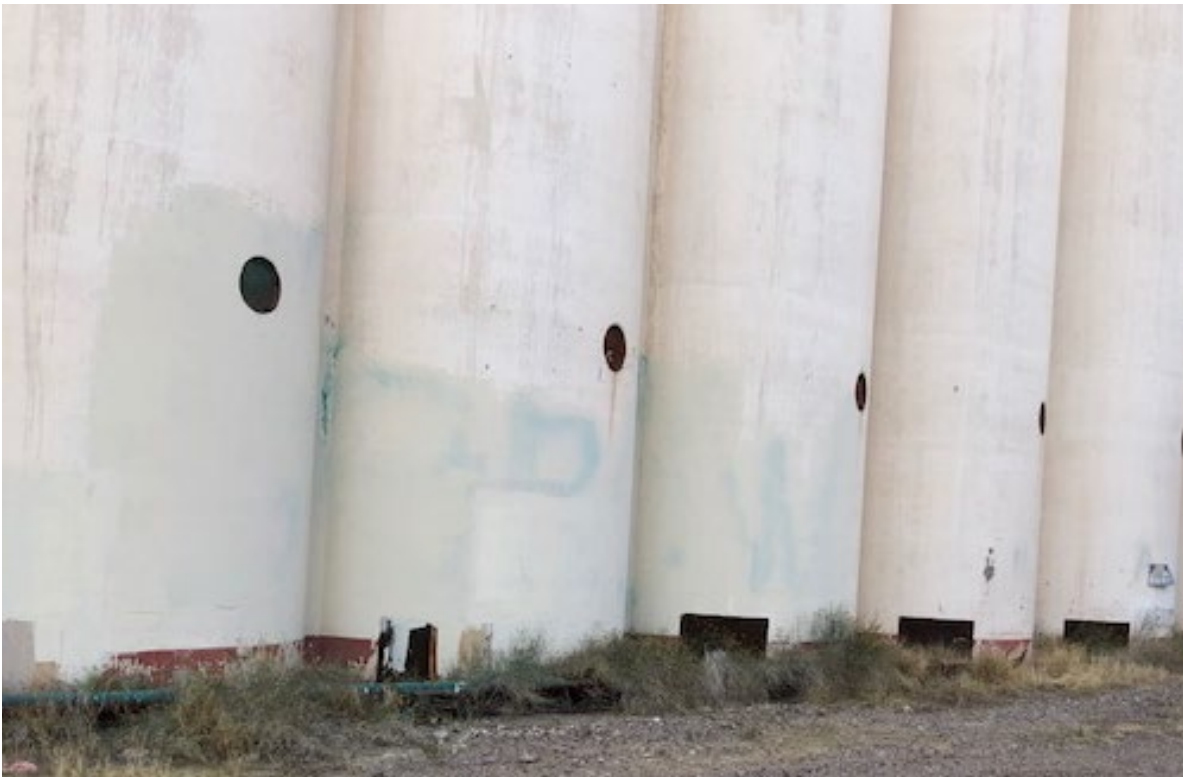
Figure 4. Photograph of exterior graffiti on the west elevation of the silos (Area 3) that had been previously painted over as an abatement strategy. Photograph taken on April 16, 2021, facing southeast.

Nearly all the graffiti was removed from the exterior elevations of the mill complex following completion of the Phase I treatment. One exception is the west elevation of the mill building (Area 1), where presumably a City employee had recently attempted to paint over a large tag rendered in green spray paint with the initials, “NMP.” The painting-over effort was incomplete and did not cover the higher-elevation of the graffiti tag, thus leaving visible the uppermost portion of the green spray-painted initials (Figure 5). Furthermore, the paint color selected to cover the spray paint did not closely match the existing paint color on the exterior wall of the mill. This painting-over effort took place sometime between the initial documentation of the graffiti on April 16, 2021 (see Figure 2) and the implementation of the abatement work on May 23, 2022.

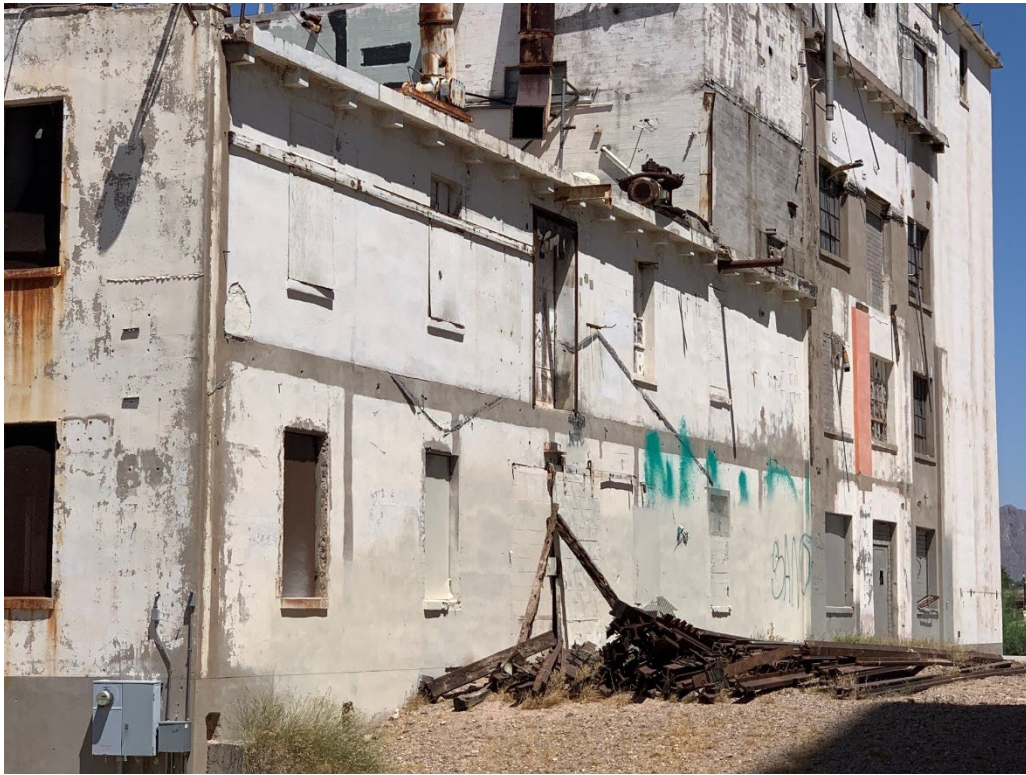
Figure 5. Photograph showing exterior graffiti tags on the east elevation of the mill complex (Area 1), including the area where the city's earlier painting-over effort is incomplete. Photograph on June 13, 2022, facing northwest.

As explained in the approved HPTP for this project (Cottrell-Crawford et al. 2022), the exterior walls of the Hayden Flour Mill complex include areas where the building and structures have been painted with acrylic-based paint, graffiti, and over spray, and areas which have previously been painted over to cover the graffiti, without being sensitive to the historical paint color and sheen. The color and sheen of the building generally extrapolated from historic images suggest that it exhibited a matte finish and a mostly off-white color, with sections of red or brown paint along the foundation; however, a more precise method for assessing the historical color of exterior walls is recommended. For example, paint colors and sheen could be matched onsite in cooperation with a qualified expert, who could do a scrape test in various locations below the existing paint layer to find the most suitable color. All future abatement efforts or modification efforts for the mill exterior should be completed in accordance with the guidelines and protocols outlined in the approved HPTP.
