CITY OF TEMPE
HISTORIC PRESERVATION COMMISSION

Subject: Agenda Item #5, Gonzales-Martinez House: Historic Preservation Update

**PHASE I ENVIRONMENTAL SITE ASSESSMENT
FOR
302 West 1st Street
Tempe, Arizona 85281
Maricopa County APN
124-24-171A**

**EEC PROJECT NO. 22022.23
AAI Date: June 26, 2023
AAI Expiration Date: March 15, 2024
REPORT DATE: July 11, 2023**

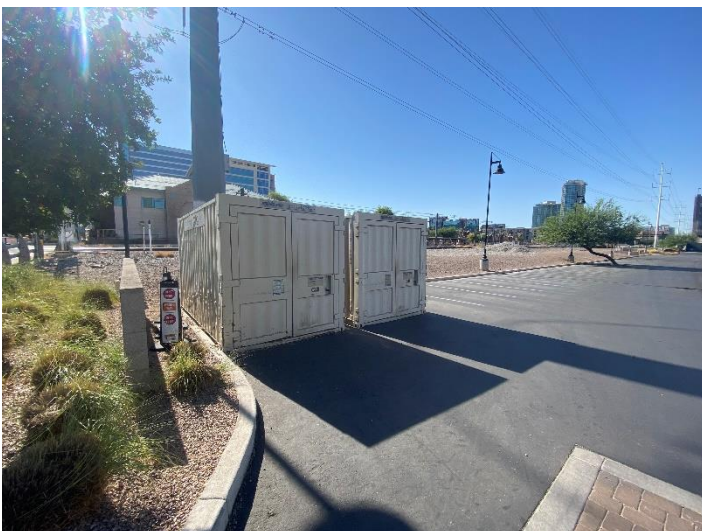
Photo No. B-2

Description: Southern portion of the subject property showing two conex boxes. No access within the conex boxes is identified as a data gap.

- EEC was not granted access to the interior of the two conex boxes located on the southern portion of the subject property at the time of the time of the site visit (Appendix B, Photos B-2). The inability to access and observe the interior of structures is identified as a data gap as defined in ASTM 1527-13, Section 3.2.21. EEC recommends the interior of the two conex boxes be inspected or removed prior to acquiring the subject property. EEC does not consider this data gap to be significant since the conex boxes can be readily removed.

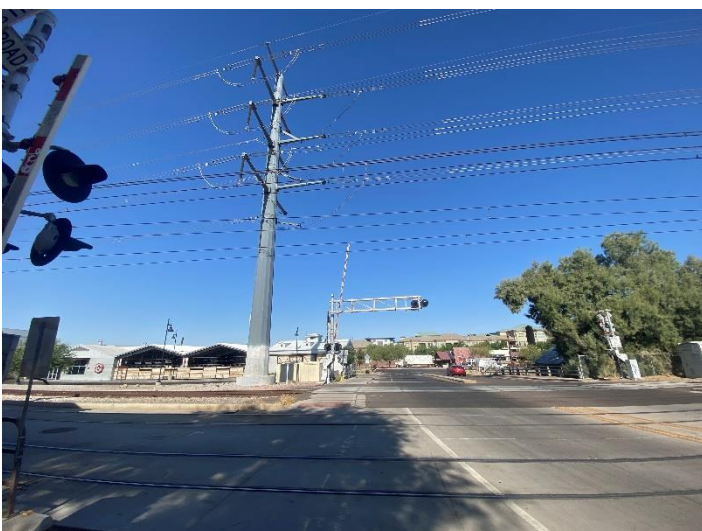
Photo No. B-3

Description: Southern portion of the subject property showing high voltage power lines.

- EEC observed high voltage power lines and underground utilities on or adjacent to the southern and northern portion of the subject property (Appendix B, Photo B-3, B-4, B-6, B-27 & B-31). The underground utilities do not represent an REC to the subject property but should be a consideration for any future development. EEC recommends that the public and private utilities in the area be properly located and marked prior to conducting any earth disturbing work at the subject property.
- EEC observed solid waste including paper, plastic and cloth within a shed (Appendix B, Photo B-22) and former chicken coop during the time of the site visit (Appendix B, Photo B-24). EEC recommends the material be removed and properly disposed. This is not considered an REC to the subject property.

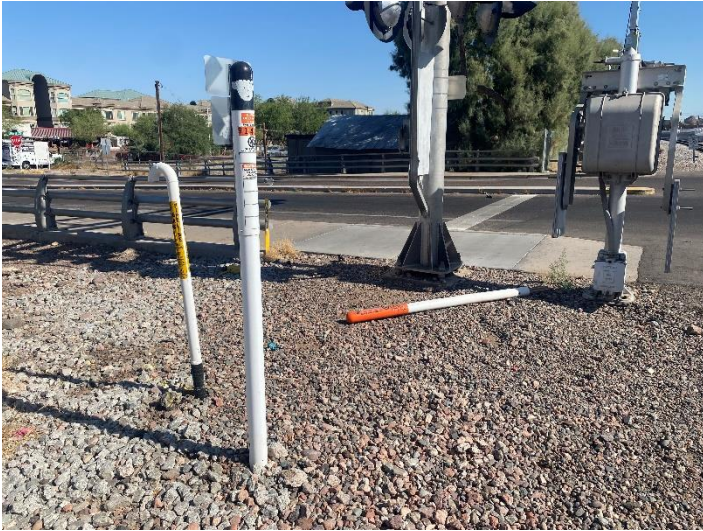
Photo No. B-4

Description: Southern portion of the subject property showing underground utilities including fiber optic and southwest gas pipeline.

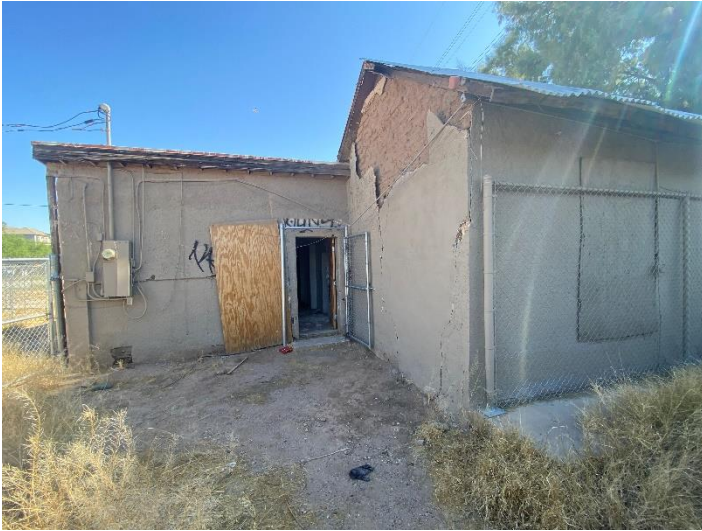
Photo No. B-7

Description: Southern portion of the subject property showing residential structure known as the Gonzales-Martinez House.

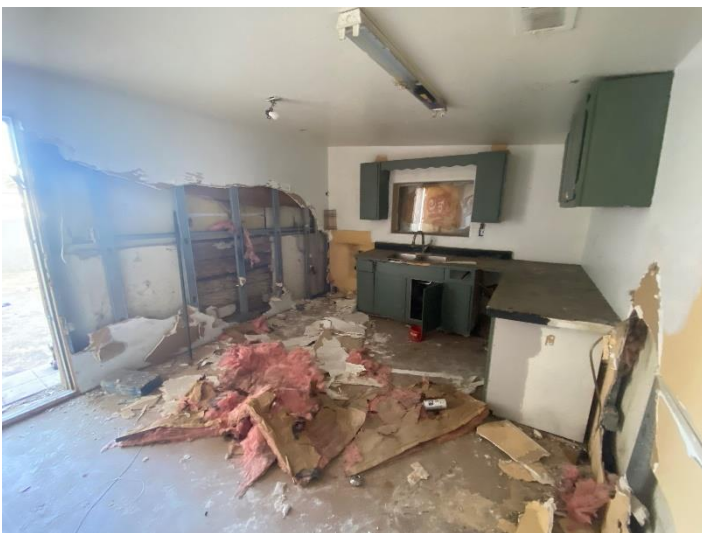
Photo No. B-8

Description: Interior of the subject property residential structure showing kitchen area.

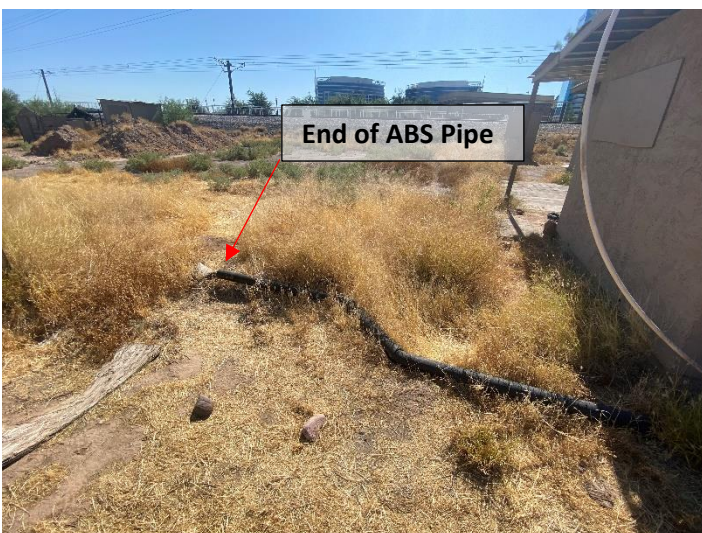
Photo No. B-15

Description: Northern portion of the residential structure showing the end of ABS pipe.

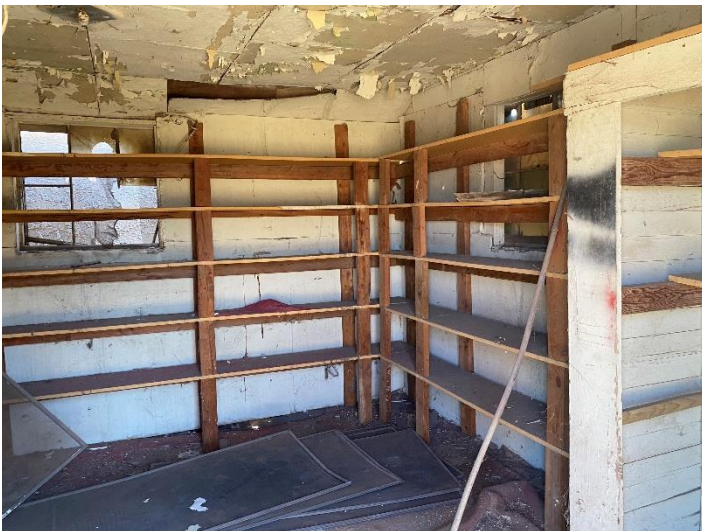
Photo No. B-17

Description: Interior of the southern shed showing storage area.

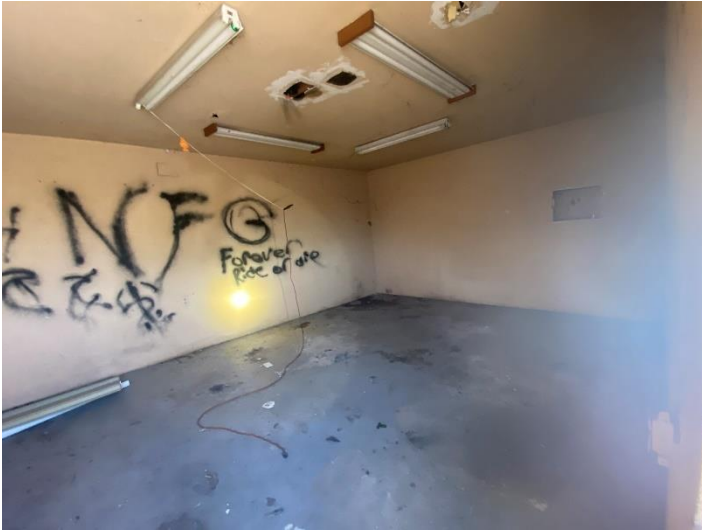
Photo No. B-19

Description: Interior of the central shed showing work area.

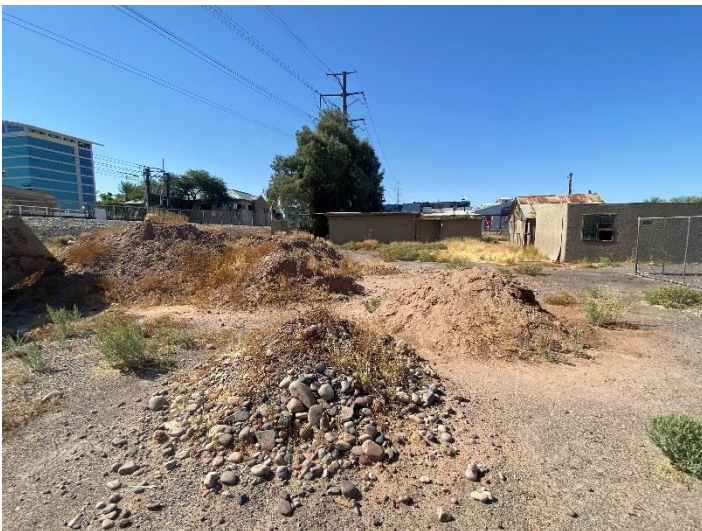
Photo No. B-20

Description: Central portion of the subject property showing inert soil piles.

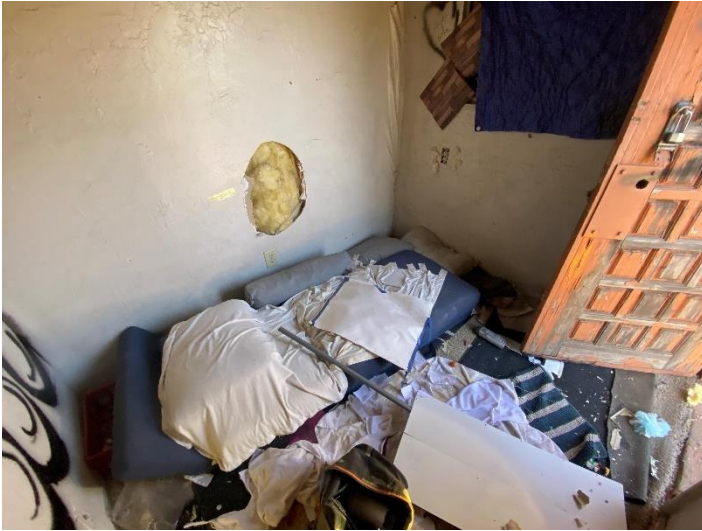
Photo No. B-22

Description: Interior of the northern shed showing solid waste including paper, plastic, and cloth.

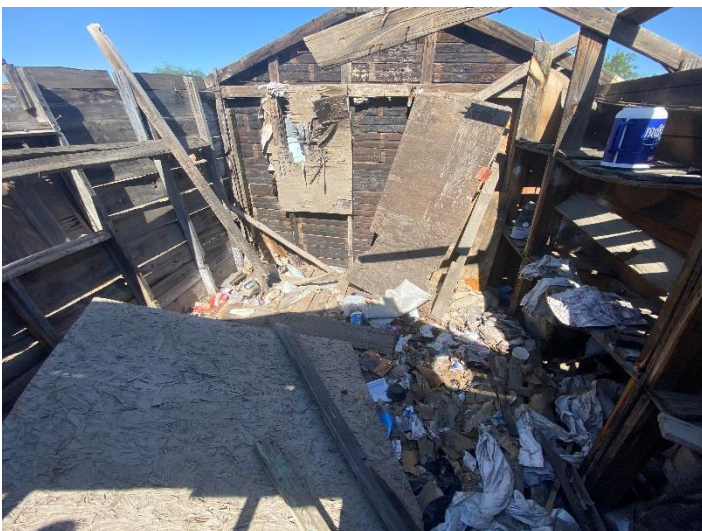
Photo No. B-24

Description: Interior of the former chicken coop showing solid waste including paper, plastic, and cloth.

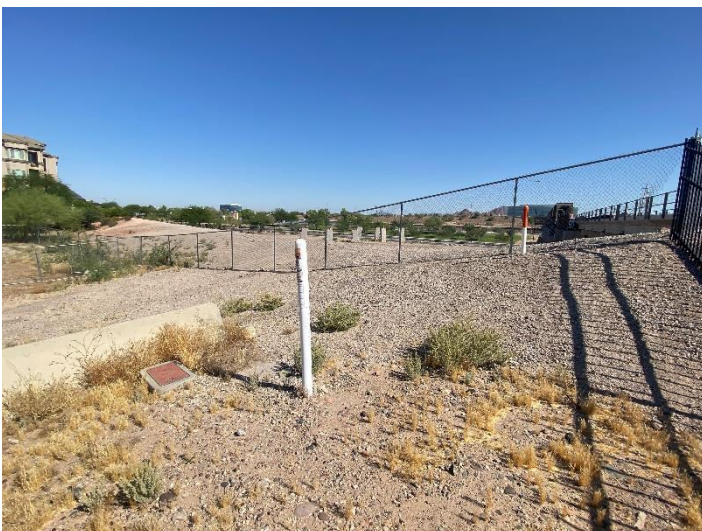
Photo No. B-27

Description: Central portion of the subject property showing underground utilities signs (fiber optic).

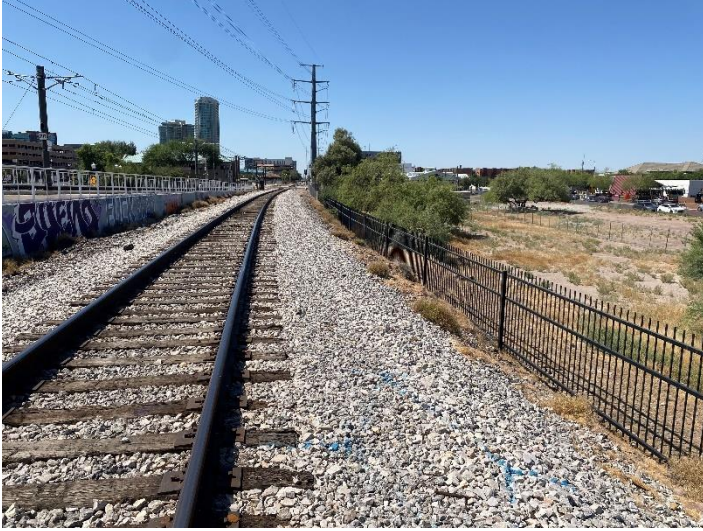
Photo No. B-28

Description: Central portion of the subject property showing Union Pacific Railroad. This portion of the railroad intercepts the subject property at the central portion and extends into the northern portion.

- Review of the historical chain of title records indicates the Union Pacific Railroad Company is located on and adjacent to the subject property. Historical records indicate the Union Pacific Railroad Company has been on and adjacent to the subject property from at least 1930 through the date of this report. The presence of the Union Pacific Railroad with the potential of industrial activities on or adjacent to the subject property is considered a potential vapor source and identified as an REC. EEC recommends a Phase II ESA including subsurface soil sampling and soil-gas survey for worker protection based on the history of the site. EEC also recommends a soil-gas survey if the current structures on the property are to be occupied or developed with new habitable structure(s). Additionally, EEC also recommends an environmental professional be contacted if petroleum odors are noted during excavation activities and a review performed for worker safety.

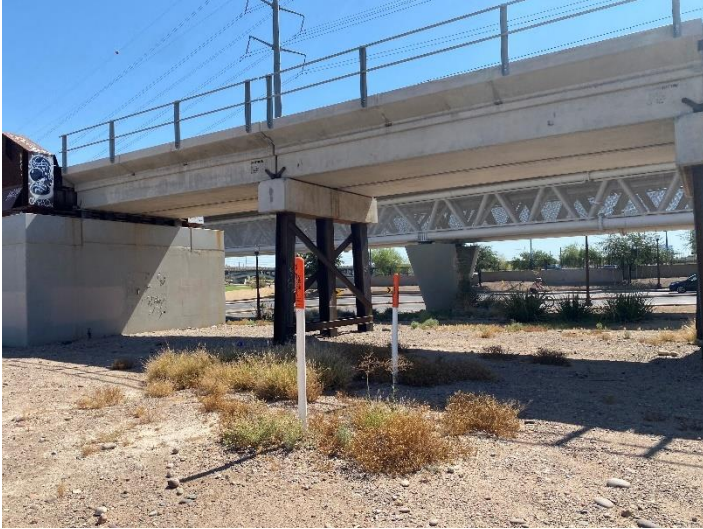
Photo No. B-31

Description: Northern portion of the subject property showing underground utilities signs (fiber optic).

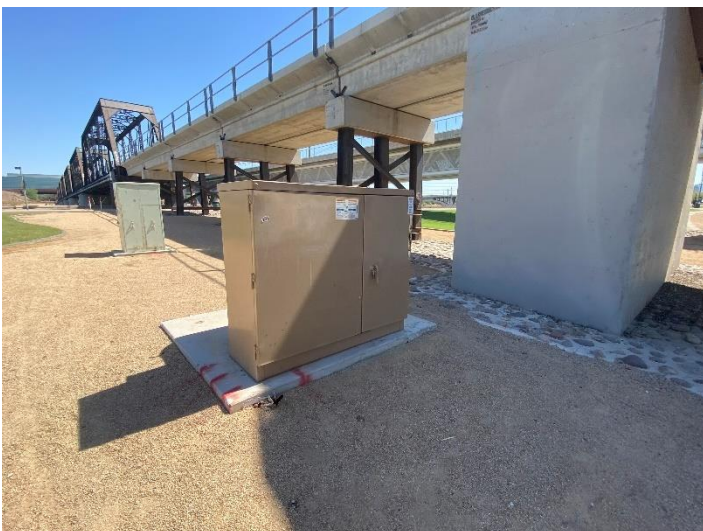
Photo No. B-33

Description: Northern portion of the subject property showing pad mounted transformer.

- One pad-mounted transformer was observed on the northern portion of the subject property (Appendix B, Photo B-33). There were no labels on the transformer to indicate that it does not contain polychlorinated biphenyls (PCBs). Therefore, the transformer is classified as contaminated (with 50 parts ppm to 500 ppm) PCBs, per Section 40 Code of

Federal Regulations, Part 761. No indication of stains or leaks was observed at the time of the site visit. If the transformer were to leak in the future or need to be removed, APS should be notified immediately and will be responsible for repair, cleanup and removal. No REC has been identified and no further action is recommended.

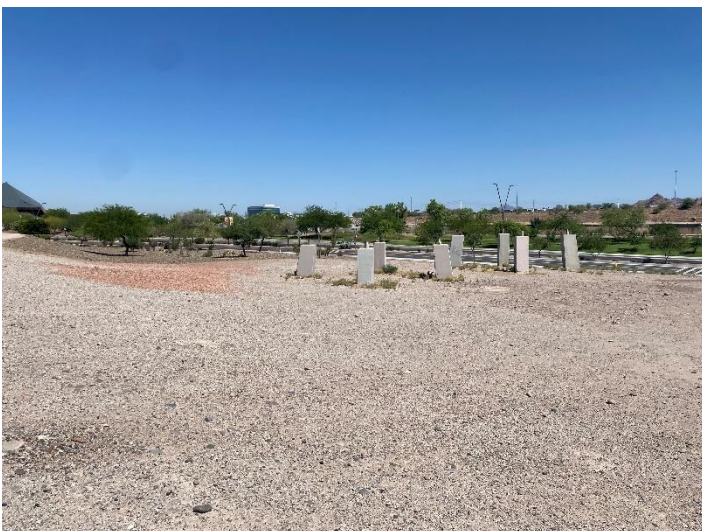
Photo No. B-36

Description: Adjacent property to the west showing vacant lot and foundations to former historical-age powerline.

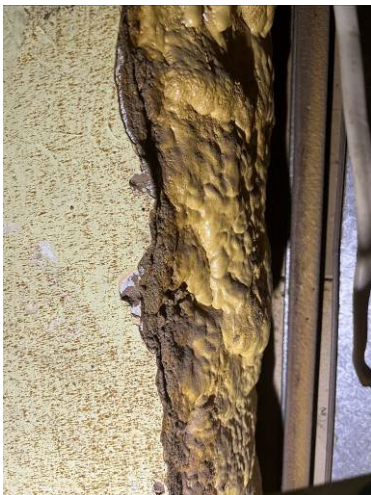
2. **Wall Materials, “Room 3” (first addition, likely historic kitchen):** All of the walls in this section of the building were covered by drywall furring in 2017. Based on information from Steve Sussex, we believed that this room and the one to the west (Room 4) to have walls built of railroad ties. Large areas of drywall furring since been damaged, exposing adobe at the north side. This wall is approximately 10 inches thick, including plaster on both sides.

The doorway through this wall (door D6 in the 2017 report) was apparently “hacked” through the wall to connect to the additions or create a closet. The jambs of the opening are irregular and were patched using masses of polyurethane foam. In this location, either the wall will need to be filled in with new adobe block, or if determined to have been a modified door or window opening, reconstructed as necessary to carry a new door or window.

Adobe wall patched with polyurethane foam

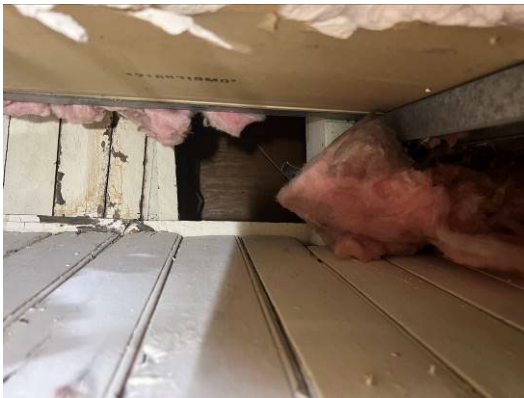
- Room 4 Roof/Ceiling Construction:** It was found that Room 4 has remnants of a wood board ceiling located about 4 inches above the current drywall ceiling. There is a small attic above that. This fact should be used to guide future restoration of the room.

View upward in north wall cavity to ceiling
