# HAYDEN BUTTE PRESERVE MANAGEMENT PLAN

May 2017

*the MOORE / SWICK partnership*  
*landscape architects and planners*  
414 S. Mill Avenue, Suite 207  
Tempe, Arizona 85281

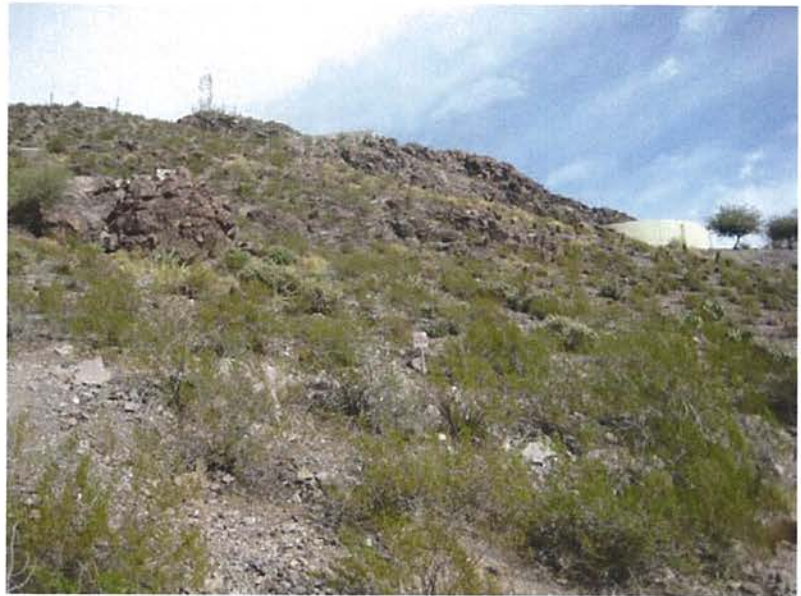
**Photo 1: Andesitic (Tv) rock exposed at the south face of Hayden Butte.**

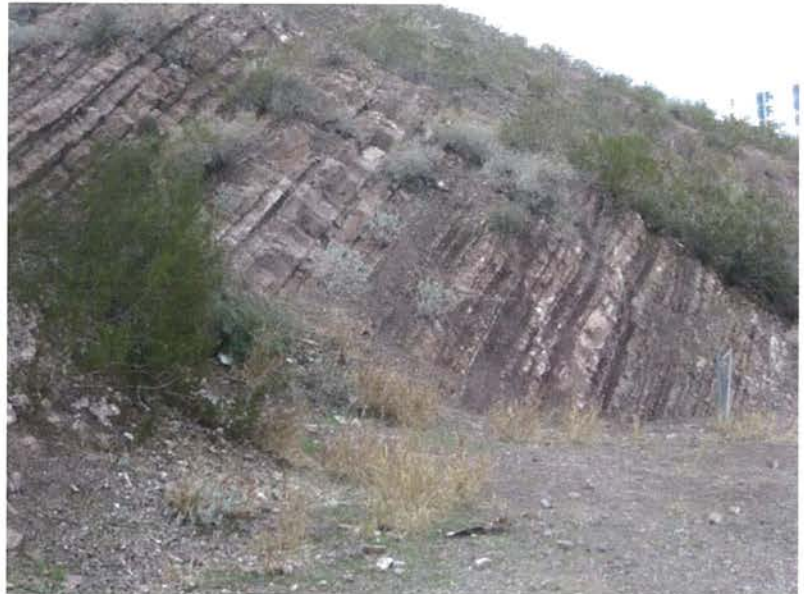
**Photo 2: Tempe Beds (Ttb) unit exposed at the northeast face of Hayden Butte.**

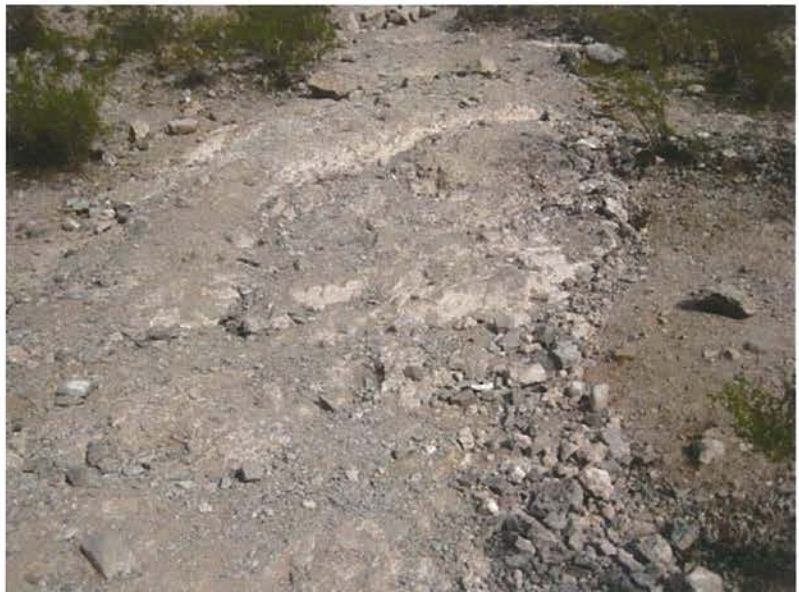
**Photo 4: Calichified colluvium at the southwest face of Hayden Butte.**

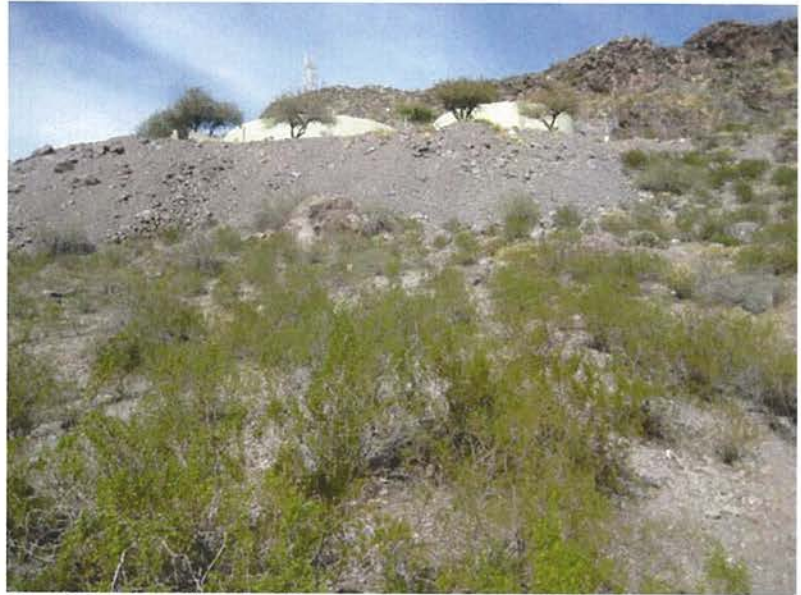
**Photo 5: Looking north at excavation spoils south of water tanks.**

The original landscape at Hayden Butte has been altered by man over time. The most significant placement of man-made fill is the result of bedrock excavations completed to construct the water tanks on the south face of Hayden Butte. The excavation spoils were deposited directly south of the tanks as shown in the following photograph:

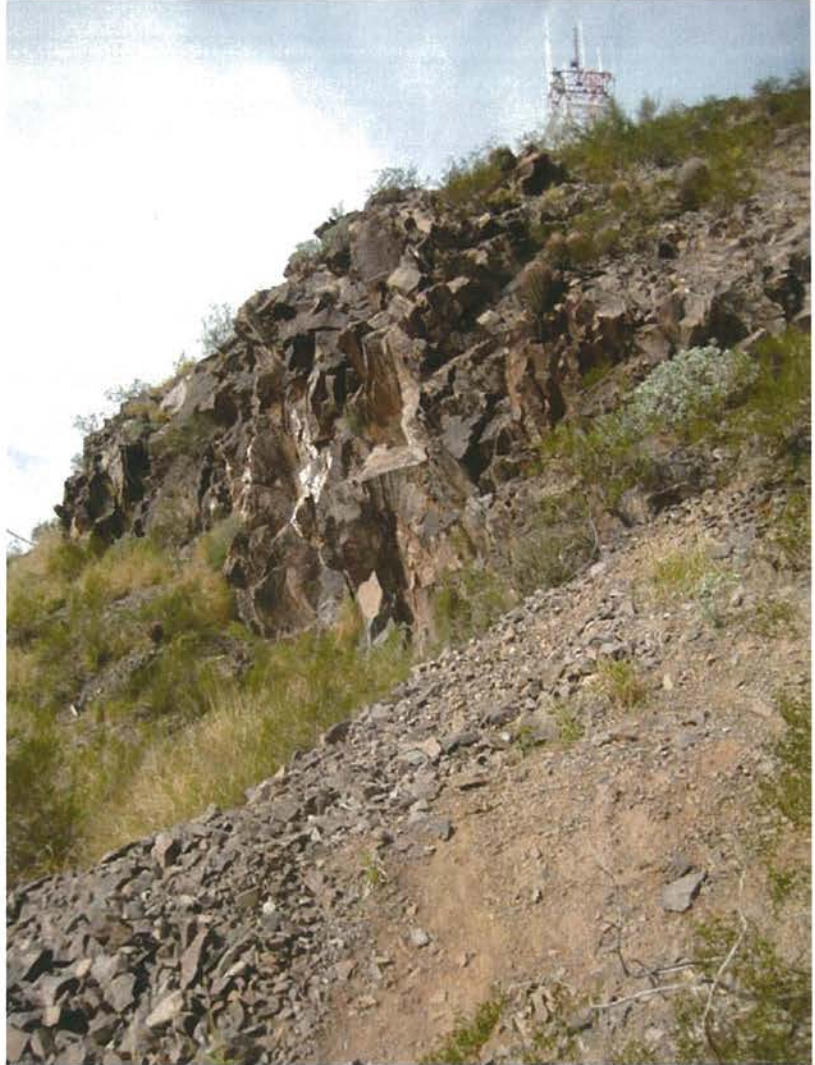
**Photo 7: Loose boulders within the man-made tank excavation spoils.**

overhanging at present. The occurrence of rock-fall events are the result of continual weathering and gravity acting on the exposed bedrock faces and on the man-made tank excavation spoils in combination with other geologic conditions. The following photos depict these conditions as observed at Hayden Butte:

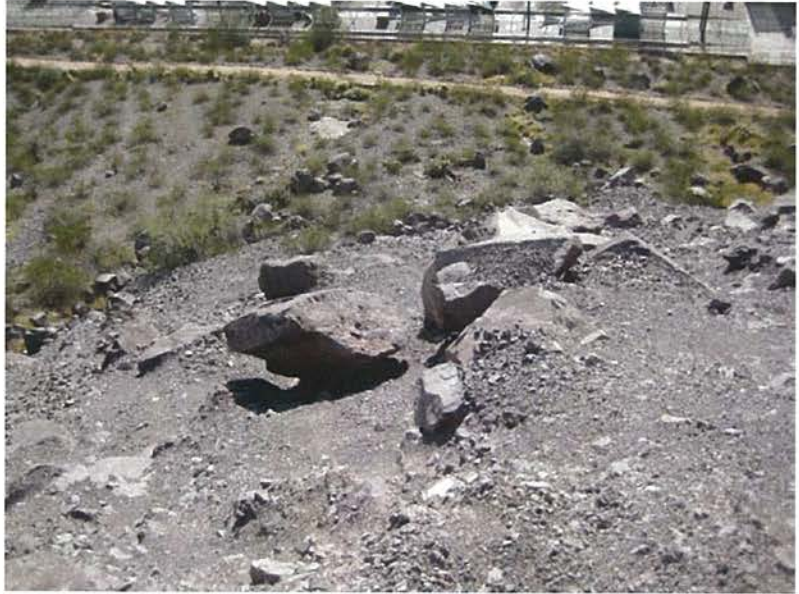
**Photo 8: Loose boulders within the man-made tank excavation spoils.**

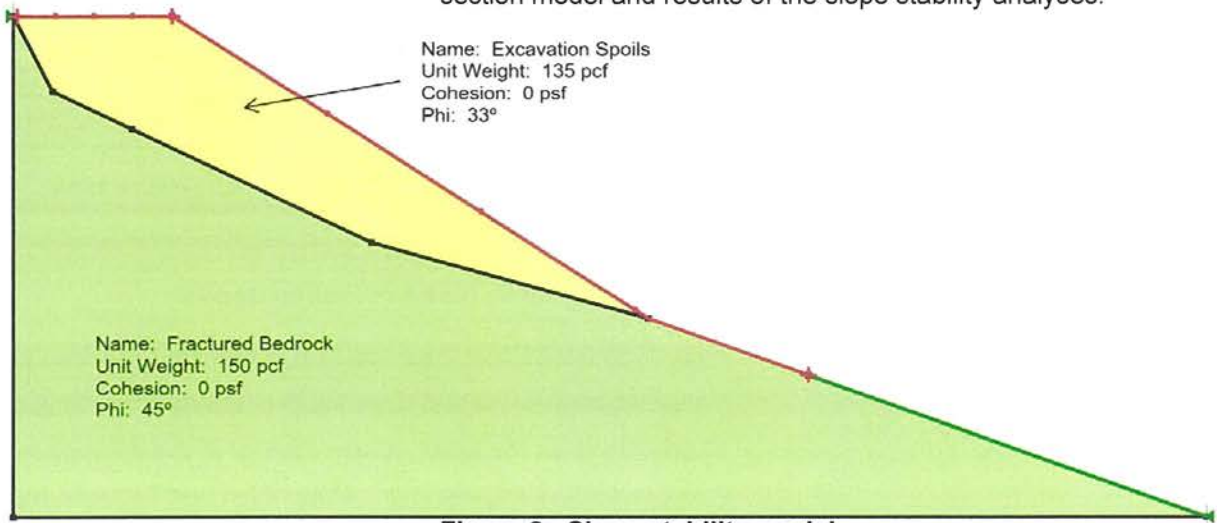
The results of the slope stability analysis indicate a factor of safety of about 1.02 for the existing excavation spoils. This factor of safety is based on the estimated natural slope inclination and estimated strength properties of the natural rock and excavation spoils material. The following figures presents the graphical cross-section model and results of the slope stability analyses:

**Figure 2: Slope stability model.**

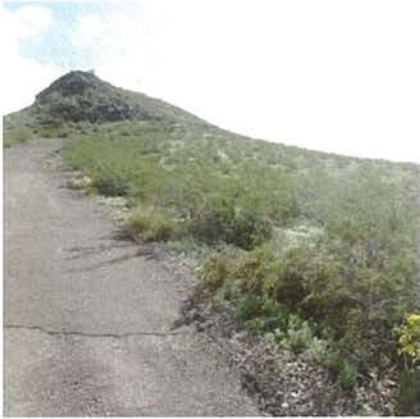
(PC-6)

When access is improved, whether for recreation trails, vehicular access roads, or utility facilities, it is generally done by creating a more gentle slope for those uses. However, where more gentle pads are created, even more severe cut and fill slopes are graded adjacent to the pad, in order to match natural topography within a short horizontal distance from the gentle pad. It is at those cut and fill slopes where erosion can be troublesome. Maintenance at these locations require strategic staff and material resources, not only to reduce erosion from the natural butte surface, but also to protect the public from unstable ground down-slope and rock-fall from upslope.

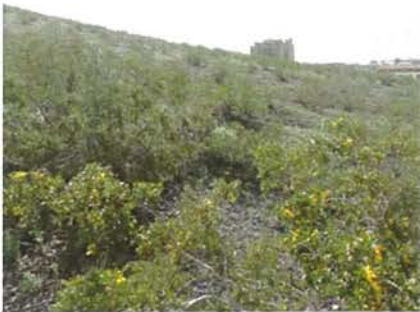
(PC-7)

Whether the butte topography remained in its natural state, or as slope modifications have been made, erosion occurs. Either following human contact or without it, wind and rain are key factors in mechanical weathering of surfaces. Results of erosion is evidenced in several forms; 1) Fine grained sediment carried in swales and channels, then deposited when the drainage course slope becomes gentle. The southerly segment of Hayden Butte is one of these areas where sediment deposits are found between lower trails and the Light Railway perimeter wall. 2) Rock cobbles can potentially fall from severe slopes. The existing water storage tank area is an example. The pad for the tanks was created by excavating a near vertical upslope and placing the excavated material down slope. Although the geologic formation generally supports this utility, occasionally cobbles will fall or roll from the slopes.

Topography of Hayden Butte is believed to support existing land use. However, it is recommended that type and location of access be planned, finished grade surfaces should be treated to reduce rate of erosion, and potential rock-fall guided away from human interface, and allow for accessibility for individuals with different levels of mobility, whenever and wherever possible.

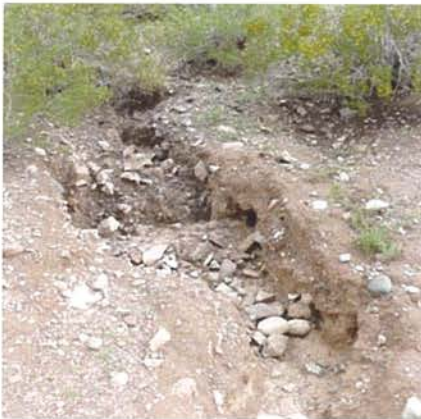
(PC-10)

Generally, these drainage channels function well and erosion is minimal with the exception of areas where the natural flow has been channeled into small culverts installed under the existing access road to the Water Tank bench, and on the hiking trails to the summit. Here the increased flow velocities tend to wash out the downstream portions of the channels where the underlying geology and/or vegetation are not sufficient enough to hold the soils in place. There is also evidence of sediment build up in the small stone sedimentation basins on the downhill side of the culverts.

Repair all erosion where it occurs in areas of bush-wacked trails, drainage channels and culverts, tailings, etc., in accordance with Section 5.2 – Recommended Management Practices.

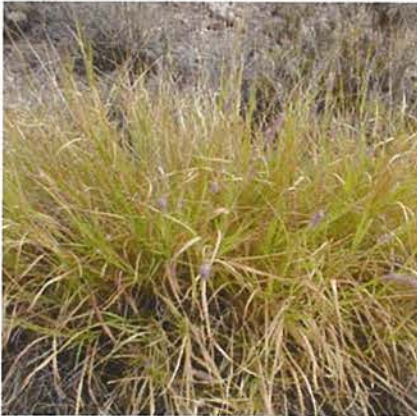
(PC 25)

**BUFFELGRASS**

Buffelgrass is a shrubby grass 1.5 feet tall and up to 3 feet wide. It looks like a bunchgrass when it's small, (either a seedling or recently burned, grazed or cut). Older plants branch profusely and densely at their nodes, giving mature plants a messy appearance. These nodal branches produce new leaves and flower spikes rather quickly after light rains, making Buffelgrass an extremely prolific seed producer.<sup>18</sup>

Begin a program to eradicate and remove all invasive, non-native Buffelgrass and Fountain Grass in accordance with Section 5.2 – Recommended Management Practices.

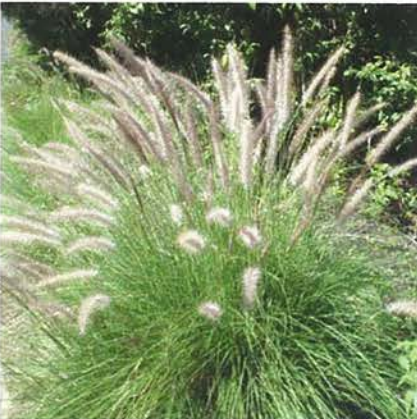
(PC 26)

**FOUNTAIN GRASS**

In addition to their tendency to spread uncontrollably, both Buffelgrass and Fountain Grass compete with native species for scarce water and nutrients. Their leaves dry when dormant or dead and produce tinder-dry fuels that quickly carry wildfires. Native Sonoran Desert plants do not form continuous stands and do not produce adequate fuels to carry wildfires. Native trees, shrubs and cacti did not evolve with fire, and are seriously damaged by it. Fires that kill native plants create even more space for exotic / invasive grasses and other non-native species.<sup>19</sup>

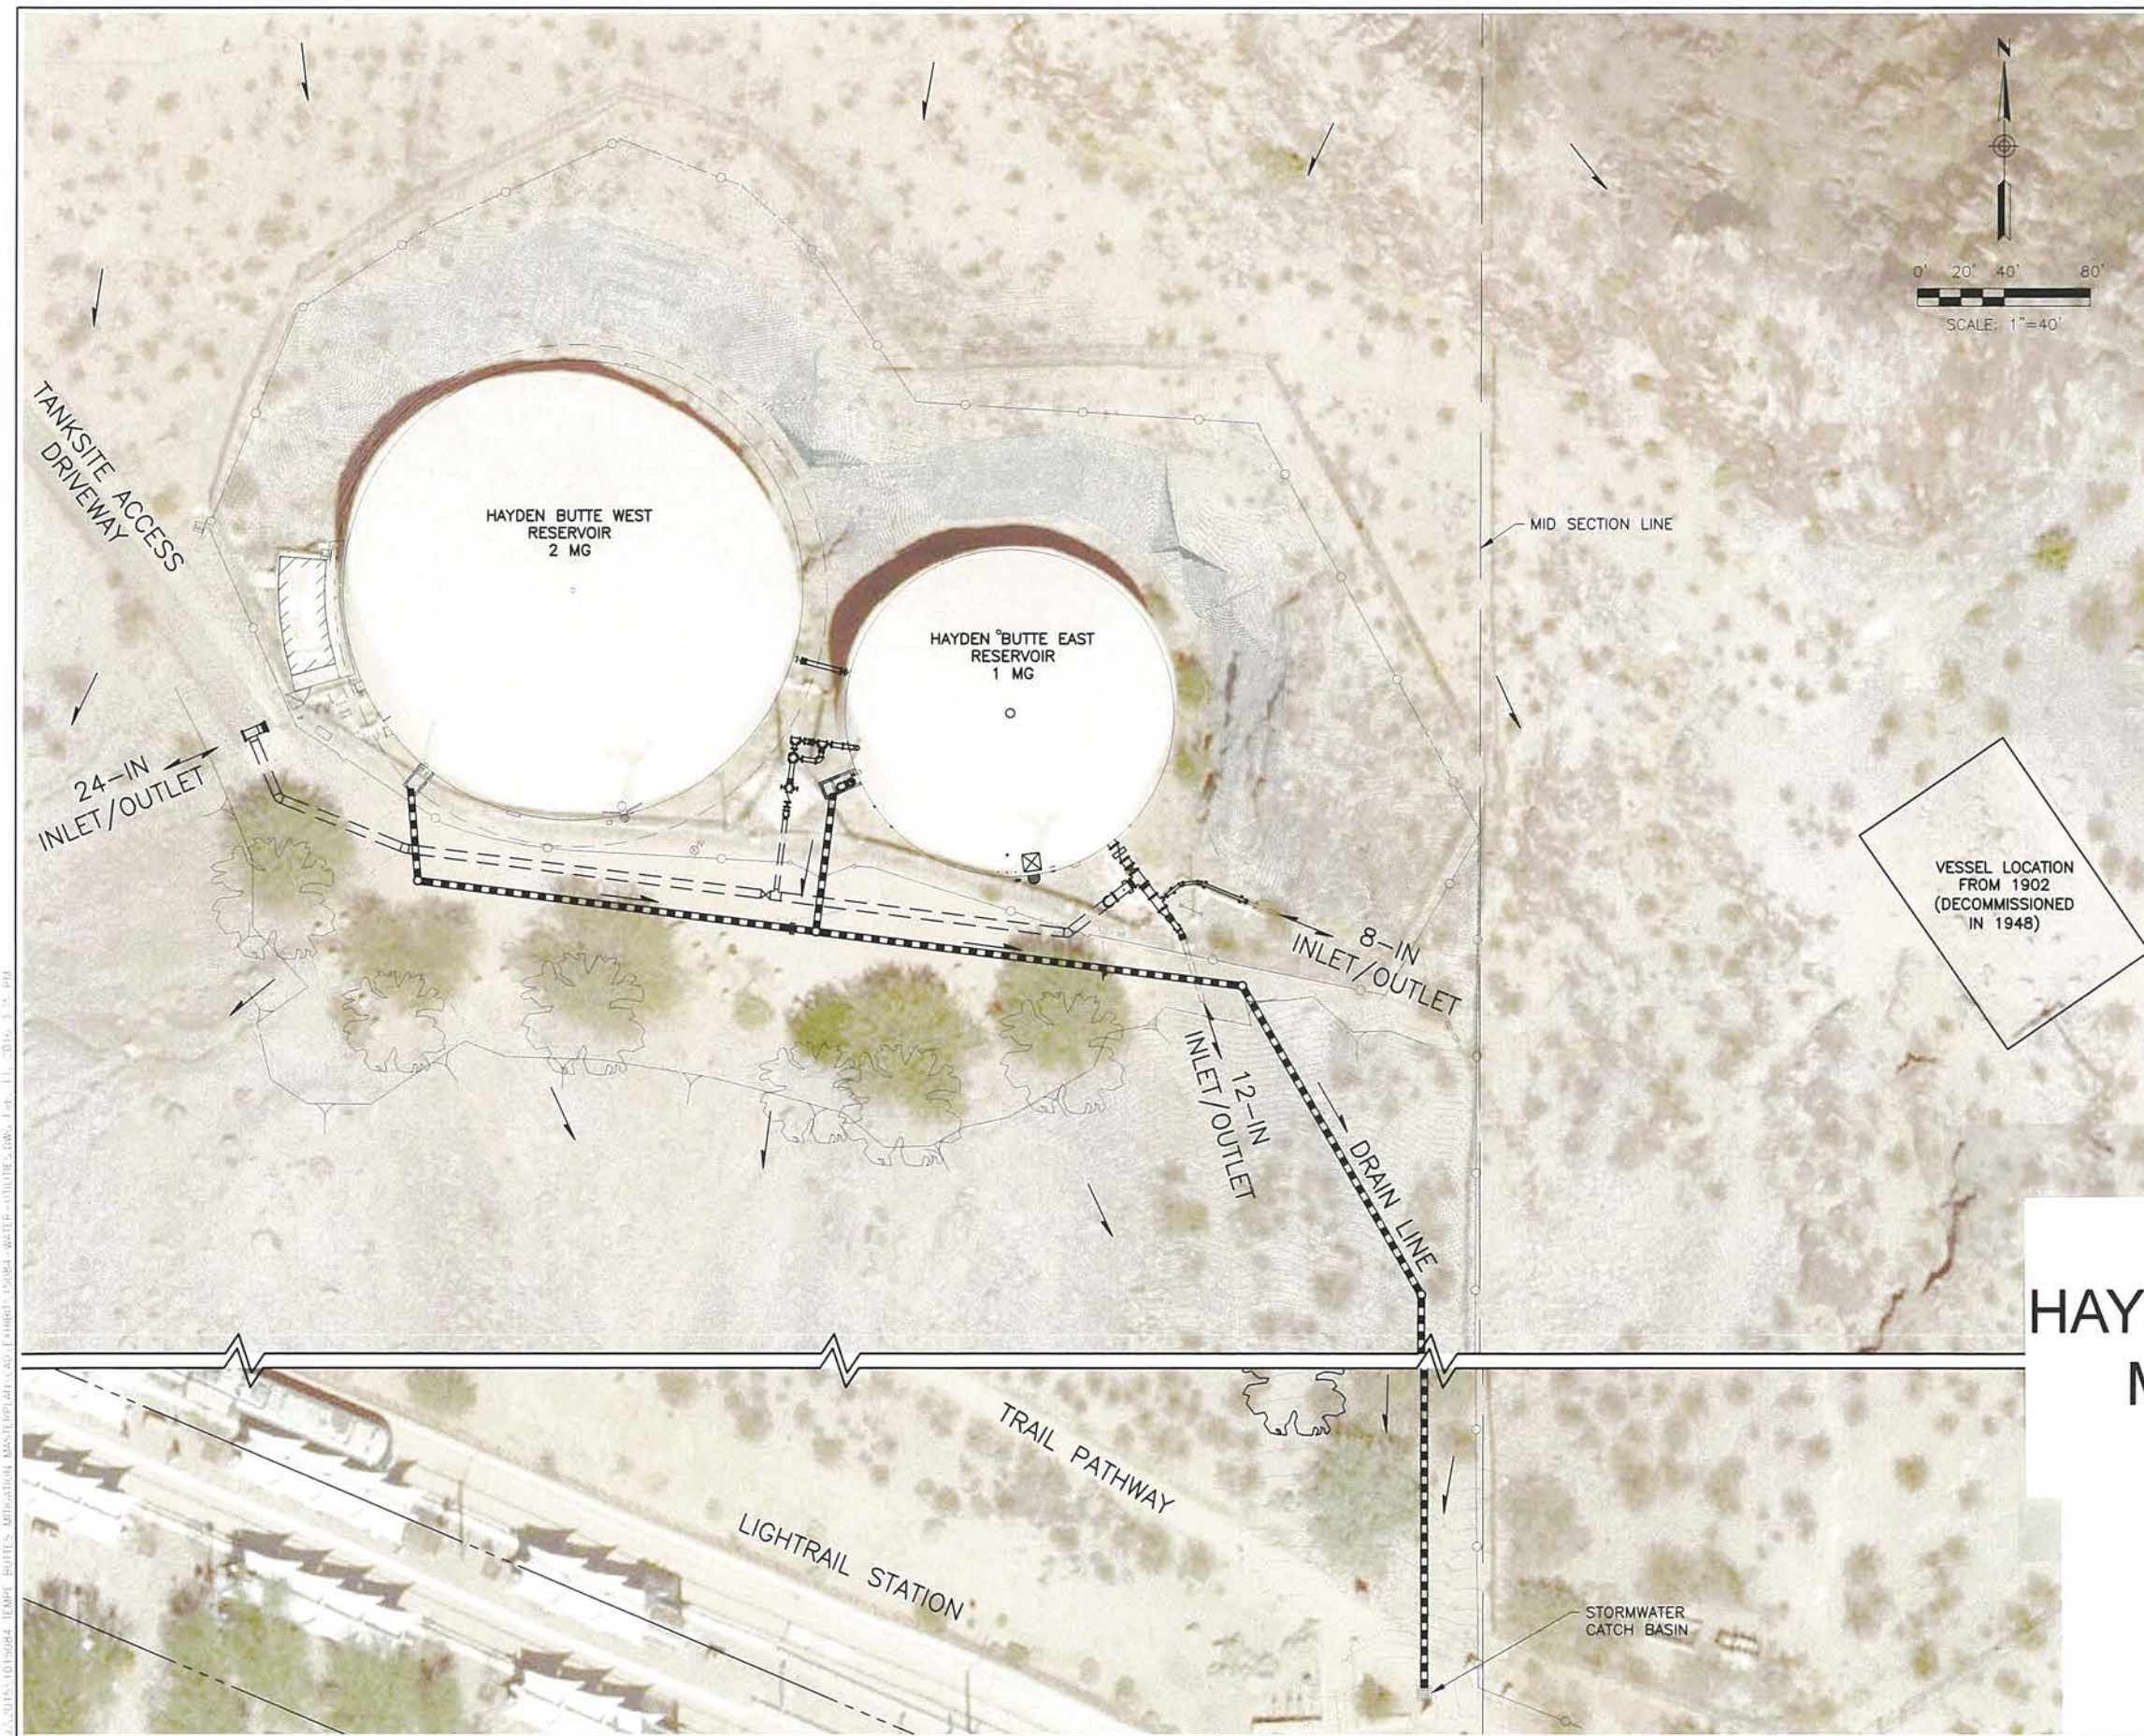
# WATER UTILITIES

In 1948 the wooden roof burned off the 46 year old water structure, and in 1949 it was replaced with a 1,000,000 gallon welded steel reservoir placed on a gravel foundation. This reservoir is located west of the old concrete/wood reservoir. It required significant hillside excavation to create a level foundation pad. The reservoir is placed on approximately 67% excavated butte and 33% fill formed from the excavated material. This is currently identified as Hayden Butte East Reservoir.<sup>55</sup>

Periodically repair, prime and paint the exterior of the two steel Water Tanks with a color that is more compatible with the adjacent undisturbed natural stone on the mountain.

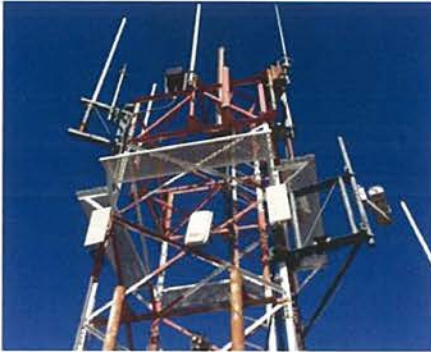
(PC 56)

The summit equipment consists of the tower, supporting equipment inside the fenced yard, and limited equipment outside the fence, including a ground-mounted cage with disconnect switches and transformer, and (3) electrical enclosures mounted to the fence.
