# **Watson's Flowers**

**A Building Condition and  
Needs Assessment of**

# Watson's Flowers

Project No. 23-012  
December 20, 2023

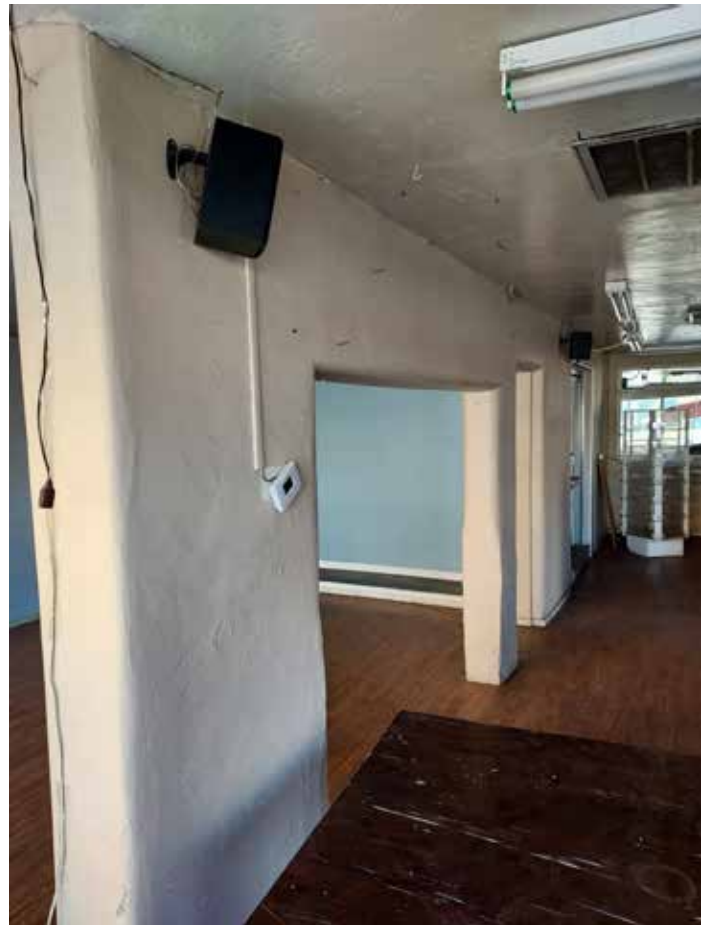
*Interior bearing wall*

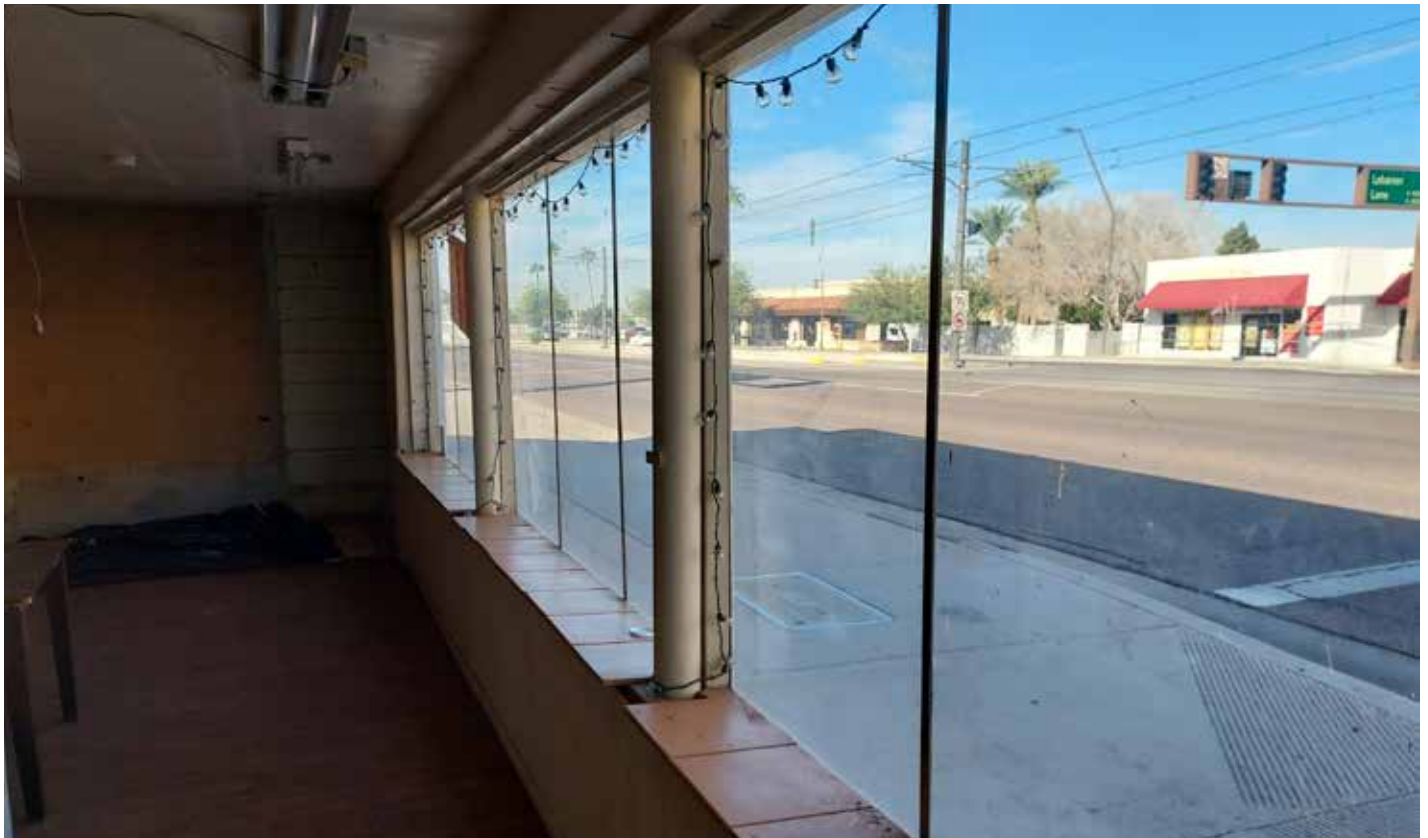
*Pipe columns at W5*

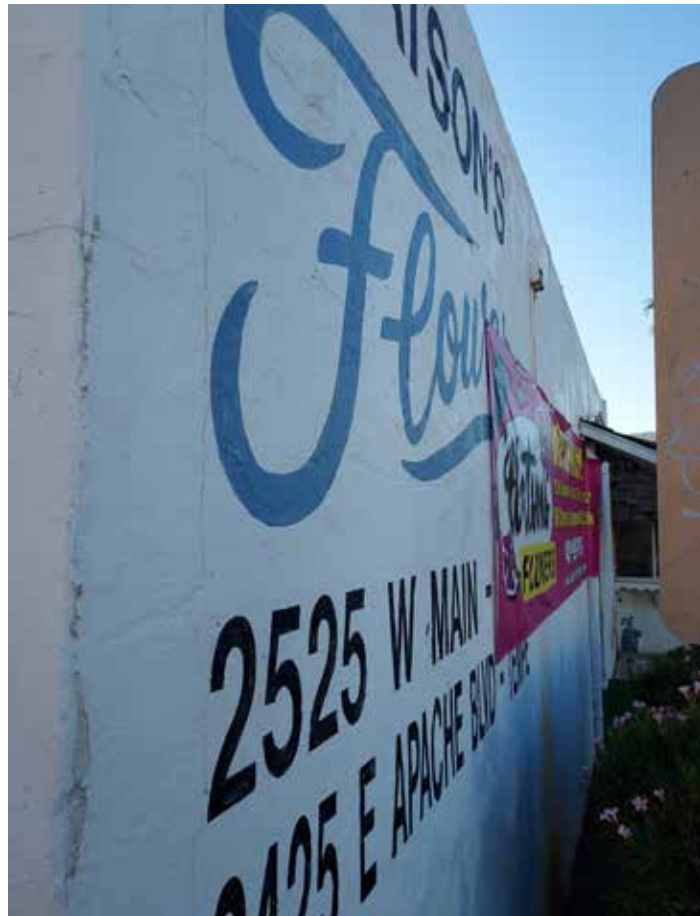
West wall texture

Loose/flaking paint should be scraped and leveled and the exterior should be re-painted. As part of the process, the smoothness of the old plaster patches might be addressed, by grinding/sanding. If spidering

of hairline cracks is found to be objectionable, an elastomeric paint may be considered.

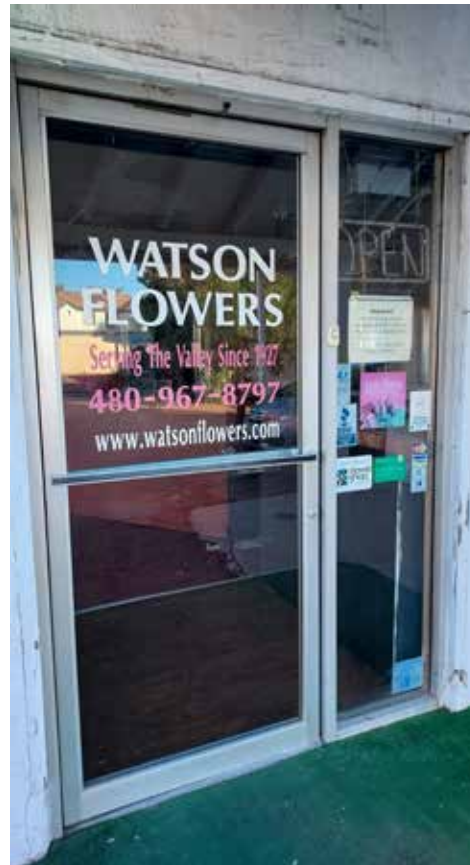
DOOR #	DESCRIPTION	DEFICIENCIES	RECOMMENDATIONS
D01	2'-10" x 6'-8" Solid core flush wood door in wood frame. Has salvaged ball tip half-surface hinges	Frame severely rotted; door is a modern replacement	Replace door and frame with appropriate style; suggest half-glass wood door, using 1930s photo as a guide.
D02	3'-0" x 7'-0" narrow stile aluminum storefront door with 2' sidelight; single-glazed; 1970s-era opening	Fair condition overall, lock broken	The door may be repaired or replaced in-kind, or it may be abandoned and infilled to eliminate it entirely.
D03	Plastered opening 3'-1" x 6'-5", that once was an exterior door to the basement.	Door and frame have been removed. Height of opening is fairly low for a door.	If the door becomes an exterior opening, a door and frame should be reinstalled to protect the basement.
D04	Wooden door frame 4'-6" x 6'-8". Frame has a rabbet on each side to potentially receive a door.	Doors originally opened inward but have been removed. Frame in good condition.	If the door becomes an exterior opening, doors should be re-installed in the existing frame.

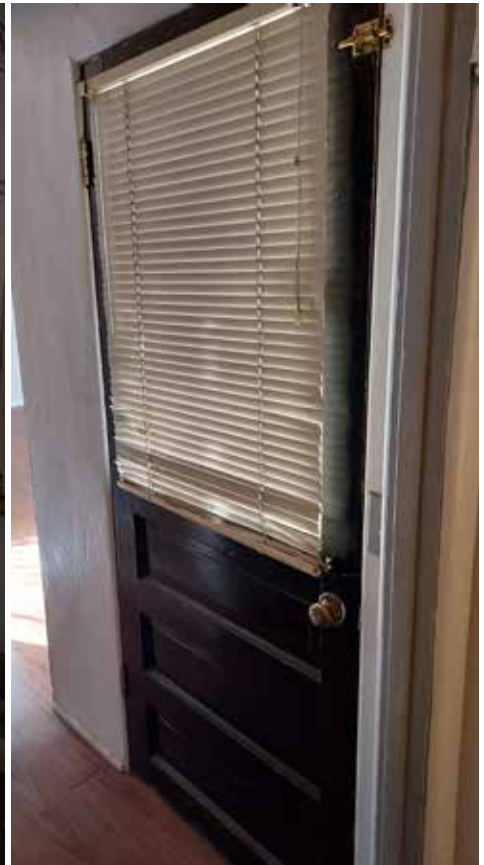
D05	Wood panel door and frame, 2'-9" x 2'-6", one glass light over three panels, stained dark both sides. Residential knob hardware, flush bolt added. Steel security door on exterior.	Possibly dates to 1953.	Preserve if practical; low-priority.
D06	Prehung embossed steel door in wood frame, 2'-6" x 6'-8", residential hardware. Steel security door on exterior.	Functional condition	Restore if practical; low-priority.
D07	Prehung embossed steel door in wood frame, 2'-6" x 6'-8", residential hardware. Steel security door on exterior.	Exterior inaccessible due to plantings.	Restore if practical; low-priority.

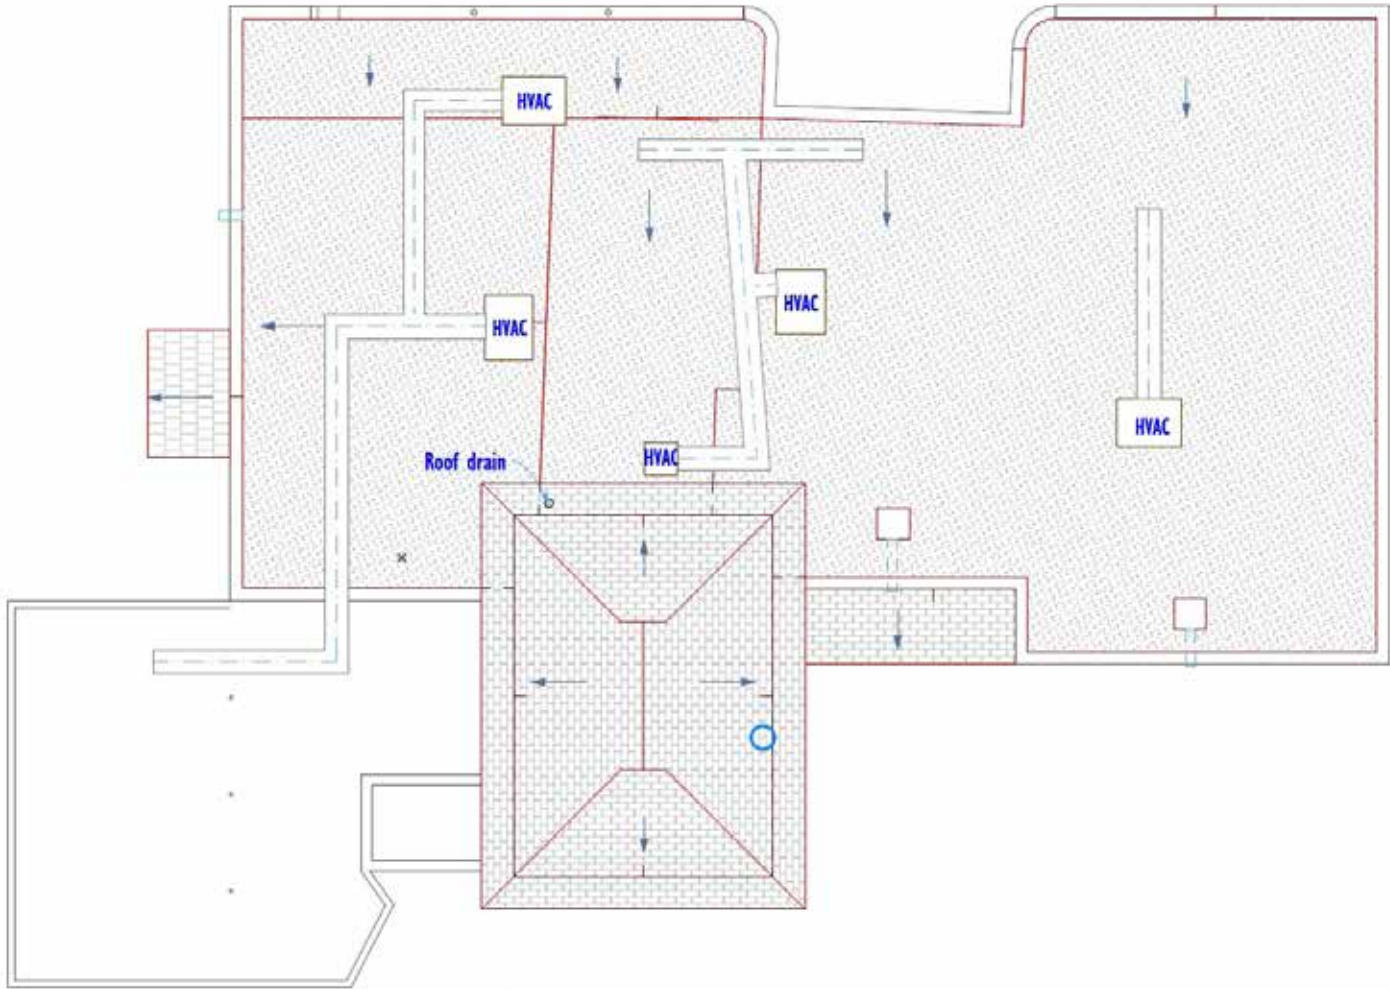
Reference Roof Plan

The roofing is in fair condition.

It would be best to eliminate the recessed roof area entirely. It may be possible to frame a new roof at a higher level, so that the area in question drains onto the adjacent roofs to east and/or west. Removal of the second-floor addition could also provide a drainage way. If there is no change to the roof configuration, the roof drain system should be replaced to ensure it is adequate and has proper outfall, and with a secondary overflow drain.

Installing secondary overflow scuppers in other areas should also be considered.

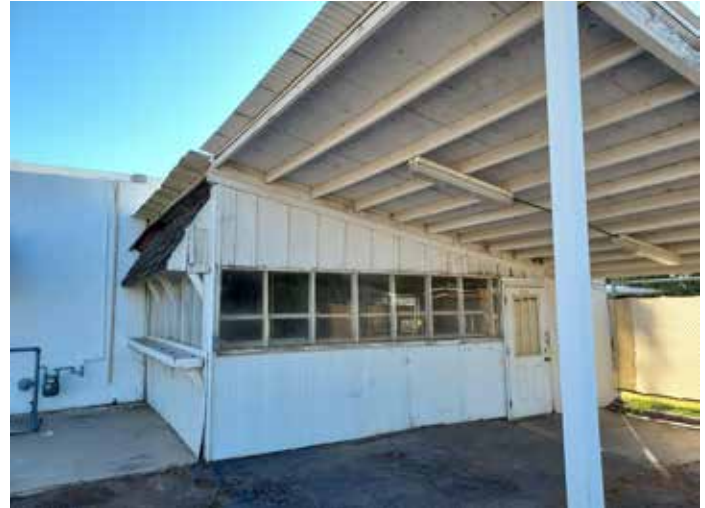
*Late Addition on west side*

The Late Addition and its porch may be removed.

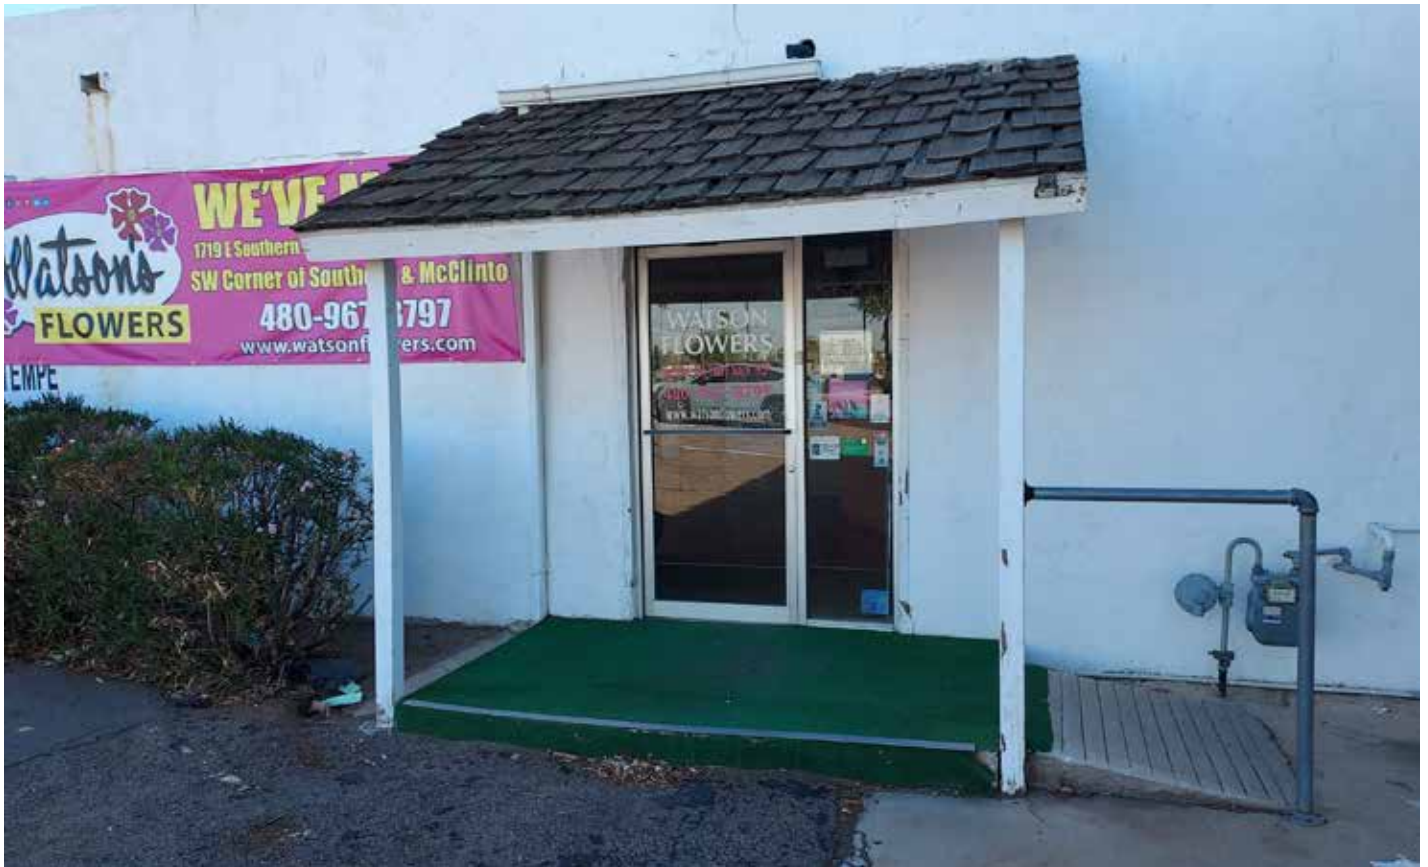
West Porch

The west porch is a fairly modern feature, dating post-1970s. It is in fair condition, but does not contribute to the building architecturally; in fact, it is out of character with the streamline design. The ramp does not meet accessibility standards.

The west porch should be eliminated or redesigned and rebuilt. The doorway it protects is not original and could be restored to a wall.

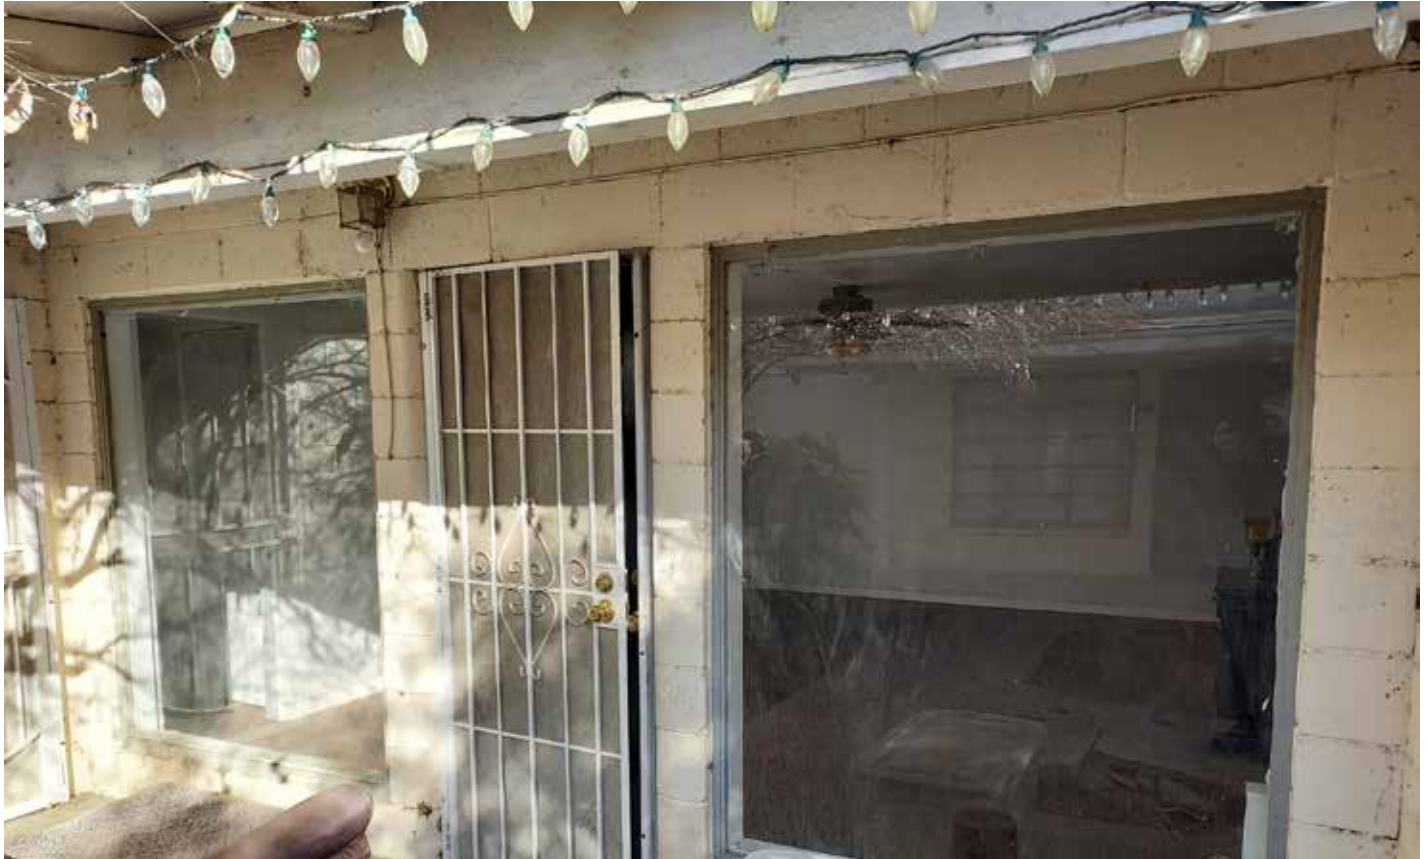
South Porch

The back porch roof is in good condition.

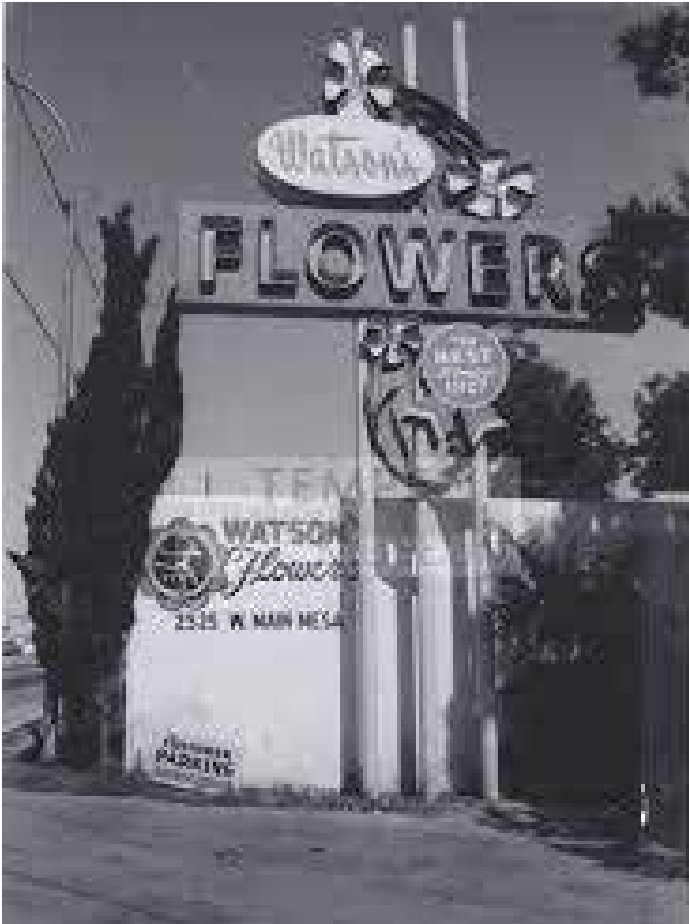
West historic sign

The freestanding sign was an important element contributing to the property’s history in commercial development along the Apache Trail. Its removal likewise damaged this integrity.

The freestanding sign should be re-acquired and re-installed if possible, although since Watson’s Flowers is still an ongoing business in two other locations, this could be confusing. An alternative would be a placeholder sign of similar character and design but

with modern words that relate to the identity of the redevelopment.

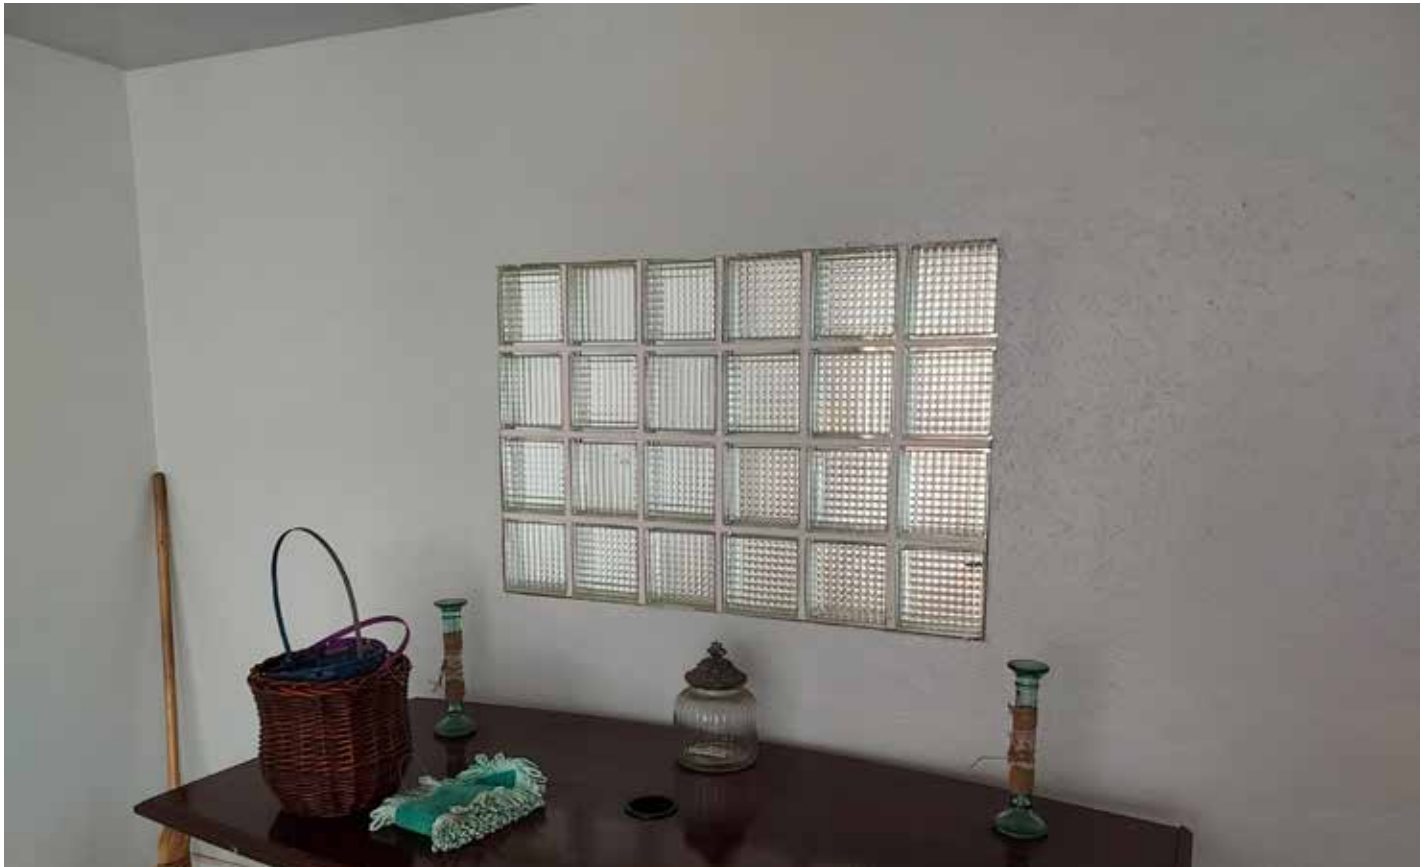
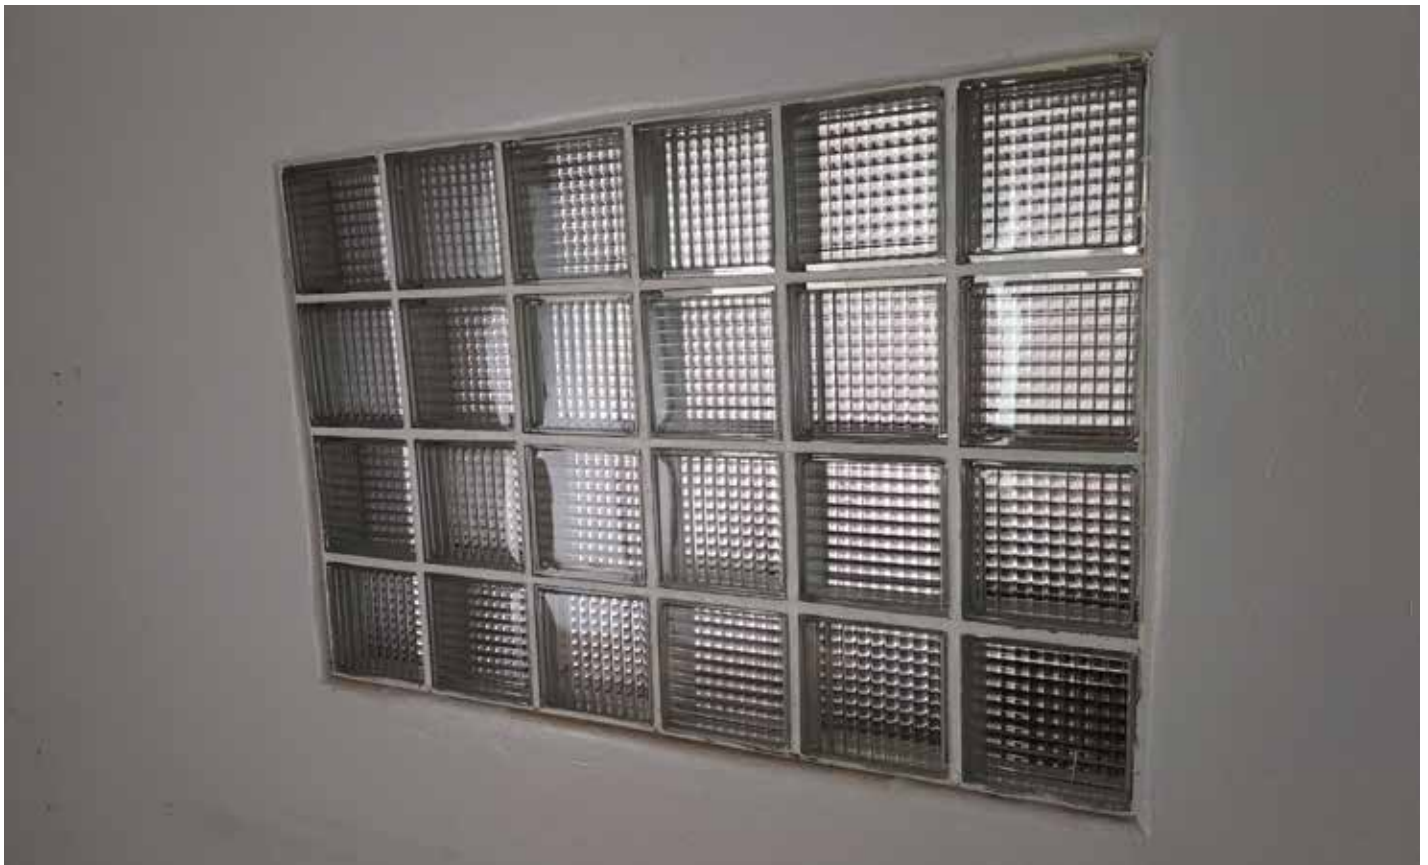
The glass block window is on good condition. It is probably not an original feature.

*Glass block window - side 01*

*Glass block window - side 02*

No work is necessary.

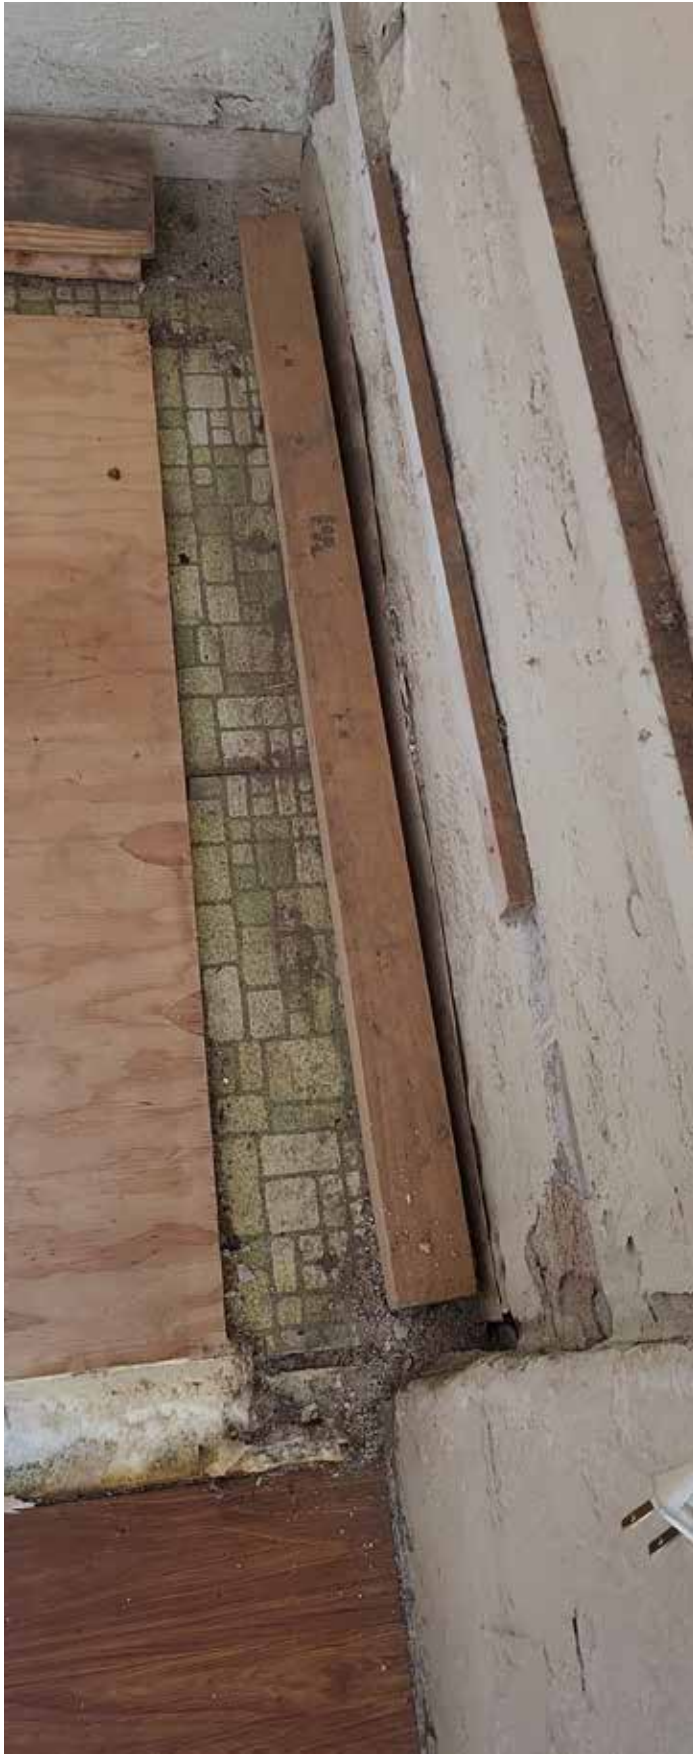
None of the existing top floor finishes are original or significant. They are in good condition overall. They are not particularly compatible with the architecture and have more of a residential quality overall.

*Sheet vinyl floor in sales*

While not a high priority, the existing floor finishes should be removed and a proper commercial appearance should be restored. Some additional destructive investigation will be required to determine the original floor finishes. Exposed, stained concrete would be a frequent choice for Moderne style commercial architecture. Vinyl tile may also have been the original finish. The vinyl-asbestos tile, and probably the mastic, will require abatement.

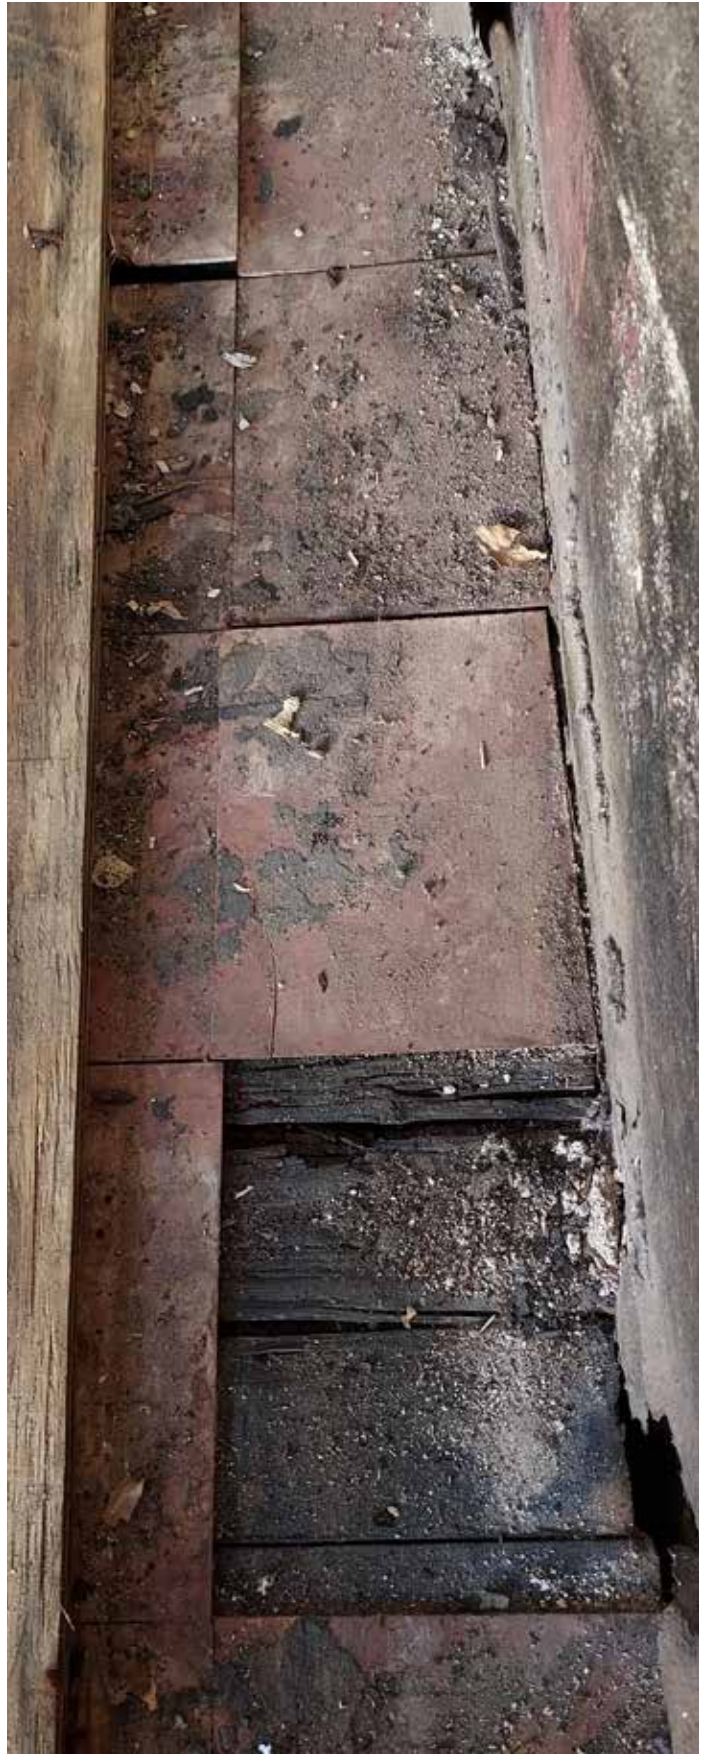
*Tile floor in sales*

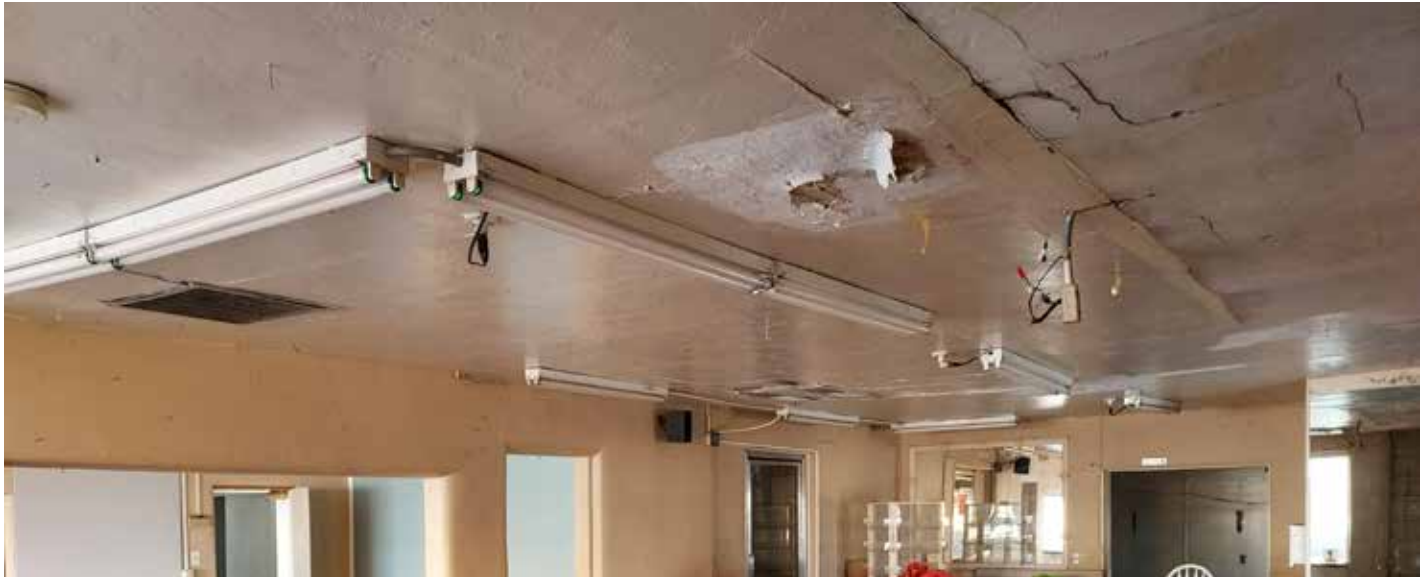
Ceilings in the western sales room have some uneven patched areas, either from changes in HVAC systems or perhaps just from roof leaks and subsequent repairs.

*Sales room 01 ceiling*

Patch, repair, and paint damaged plaster. It may be necessary to remove some or all of the plaster ceilings in order to access the structure and/or insulate the roofs. Since the plaster work is not decorative, removal and replacement with drywall would not significantly erode the architectural integrity.

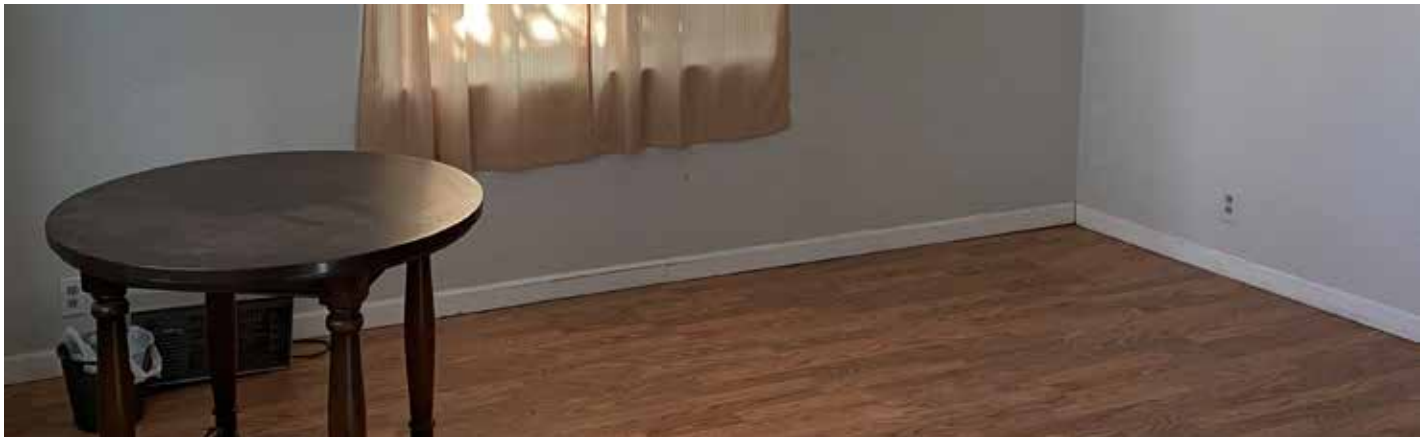
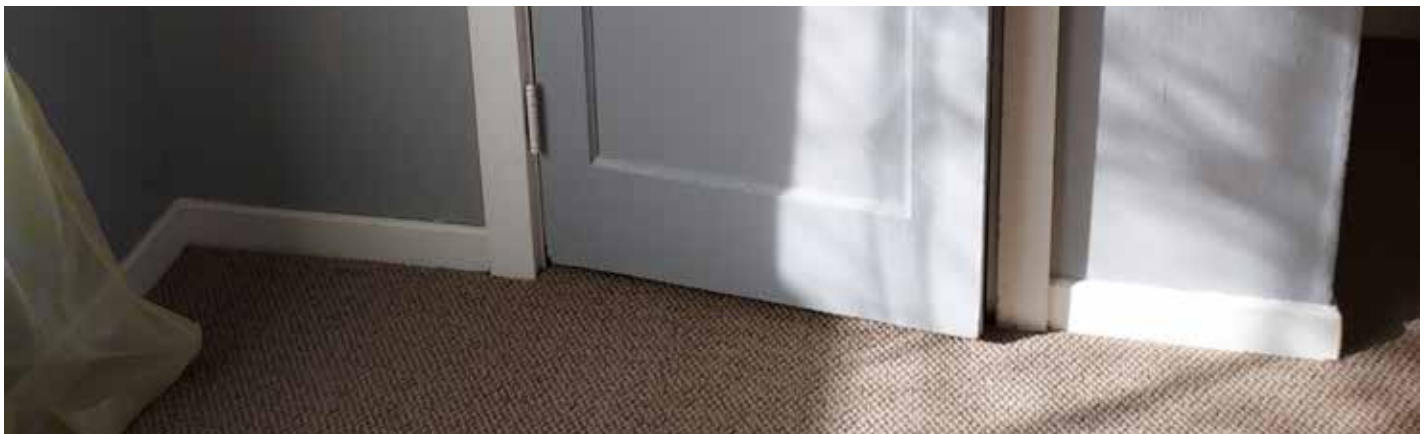
The wood base is in fair condition; the finishes are a bit uneven in some places. The vinyl base is modern and detracts from the interior historic character. None of the cabinetry or other casework is significant or contributing.

*4-inch wood base*

Preserve wood base where it remains. New interior rehabilitation work should incorporate wood base and should continue the minimalist character of trim work. Existing casework, kitchen cabinets, and bathroom vanities may be removed as needed.

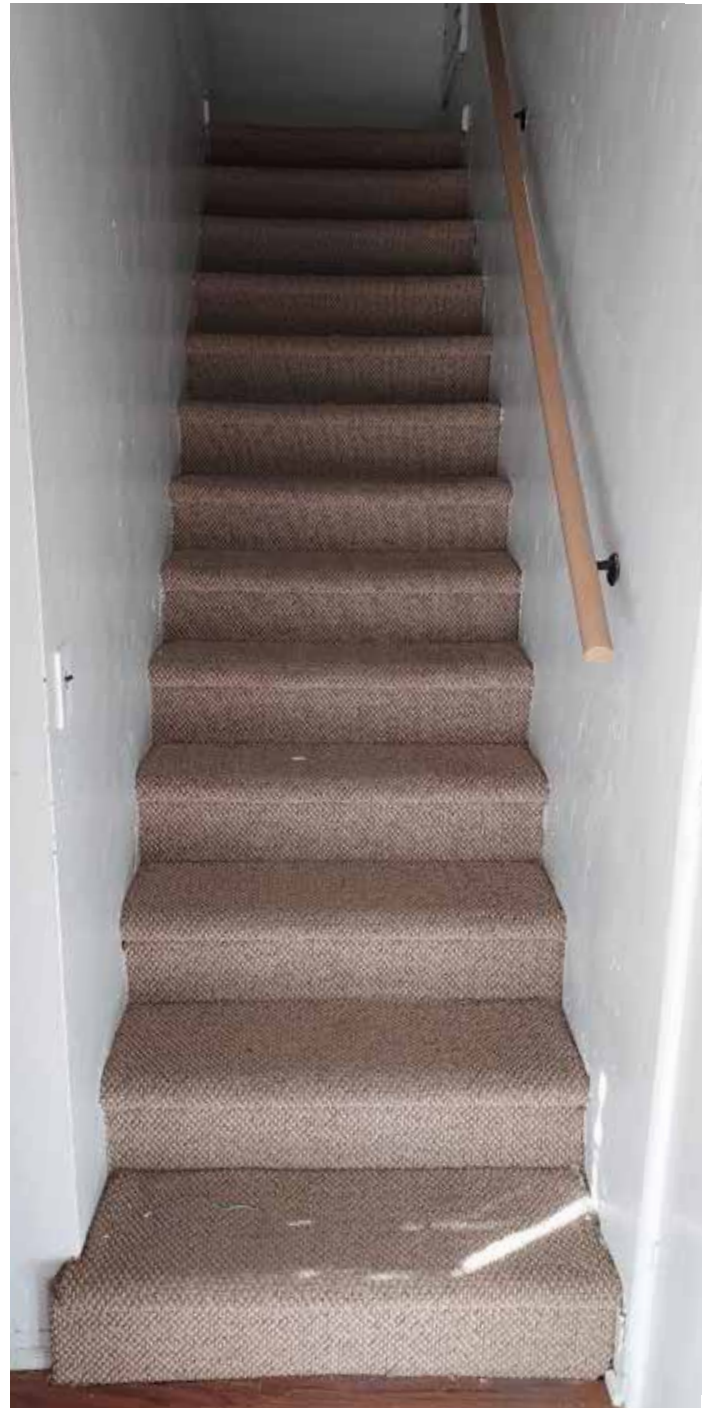
Stairs

The second floor stairs are in good condition; however, they do not meet modern code requirements for width, rise/run, and railings, particularly for a commercial use. They are not considered to be a character-defining element of the building.

Some allowance for preservation and reuse of the stairs may be allowed by application of the Existing Building Code, as approved by the building official. However, their removal and/or alteration would also be allowable. As a minimum, the stairs should be made to meet NFPA Life Safety Code for existing buildings.

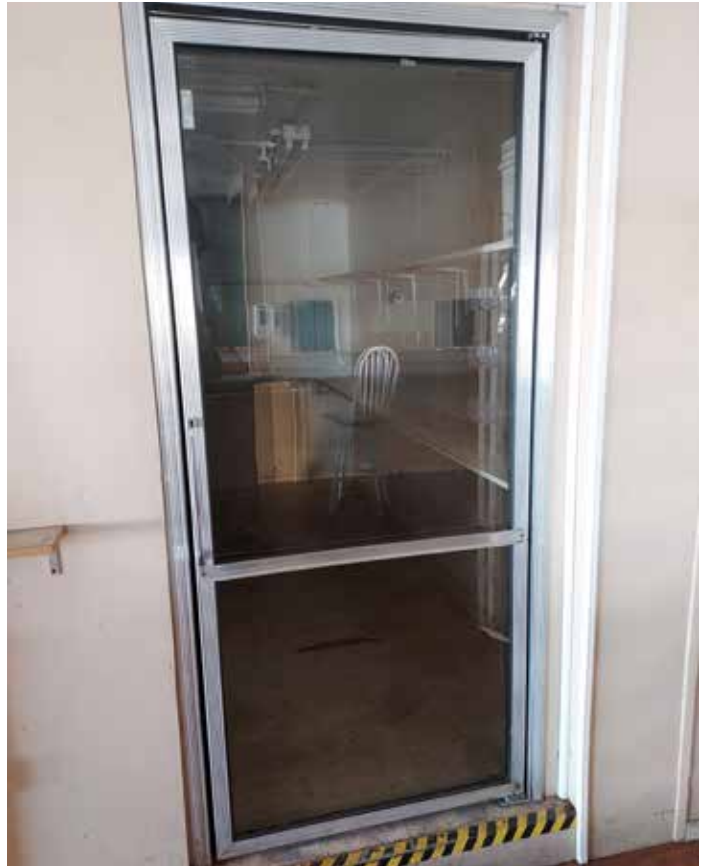
*Refrigerator door 01*

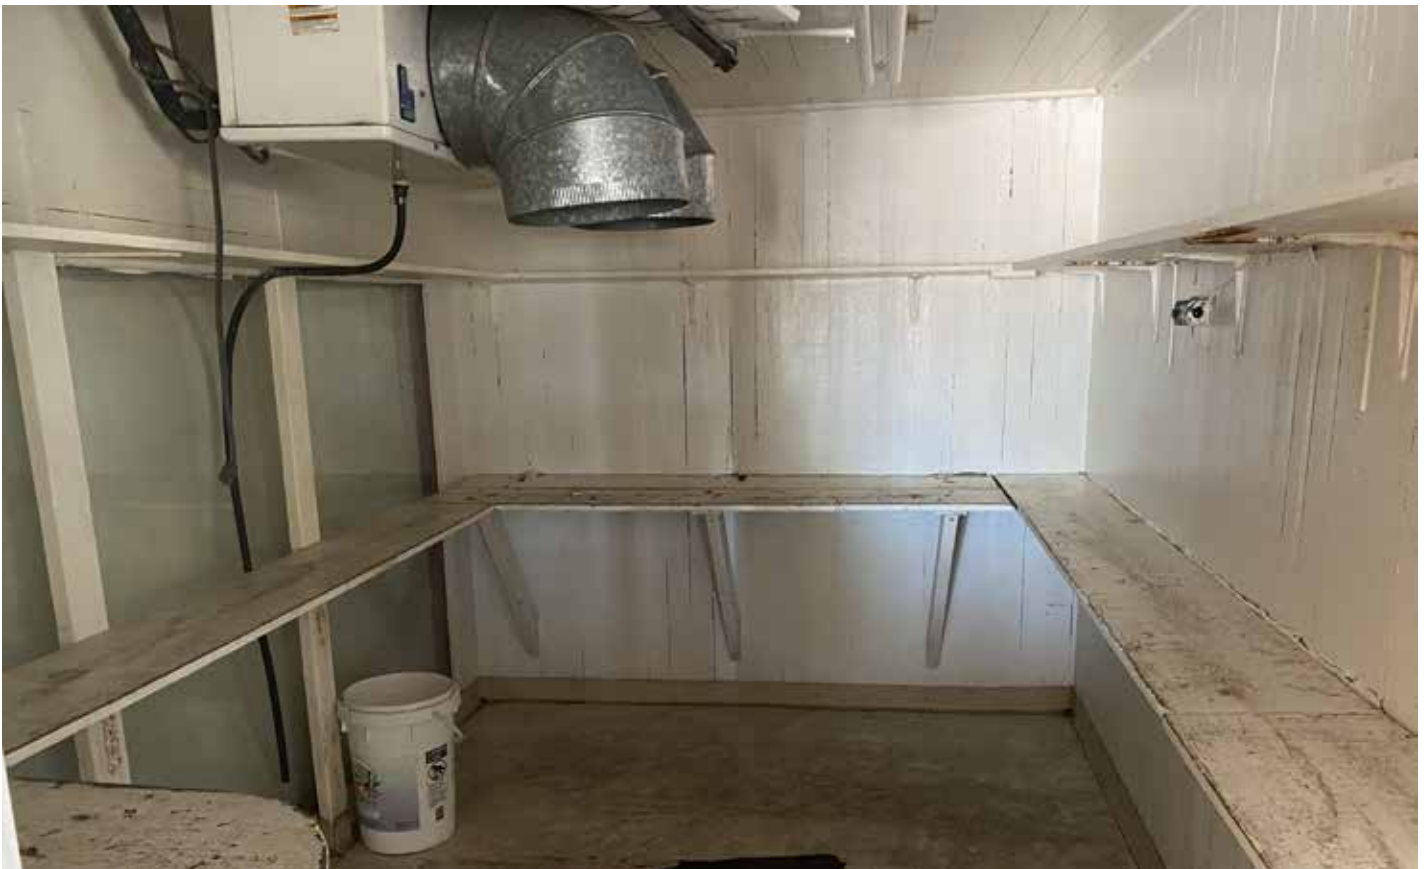
*Refrigerator Interior 01*

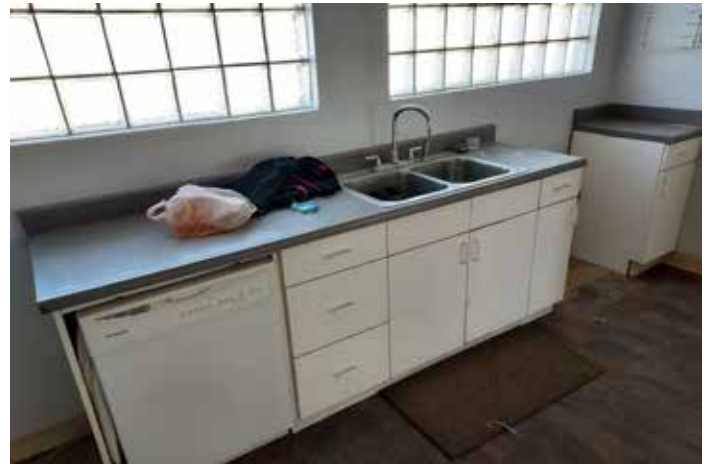
*Kitchen sink*

Piping systems should be more closely evaluated by an engineer or contractor to determine their age and condition, if they are to be reused. Plumbing fixtures may be reused or replaced, as needed, for a future rehabilitation.

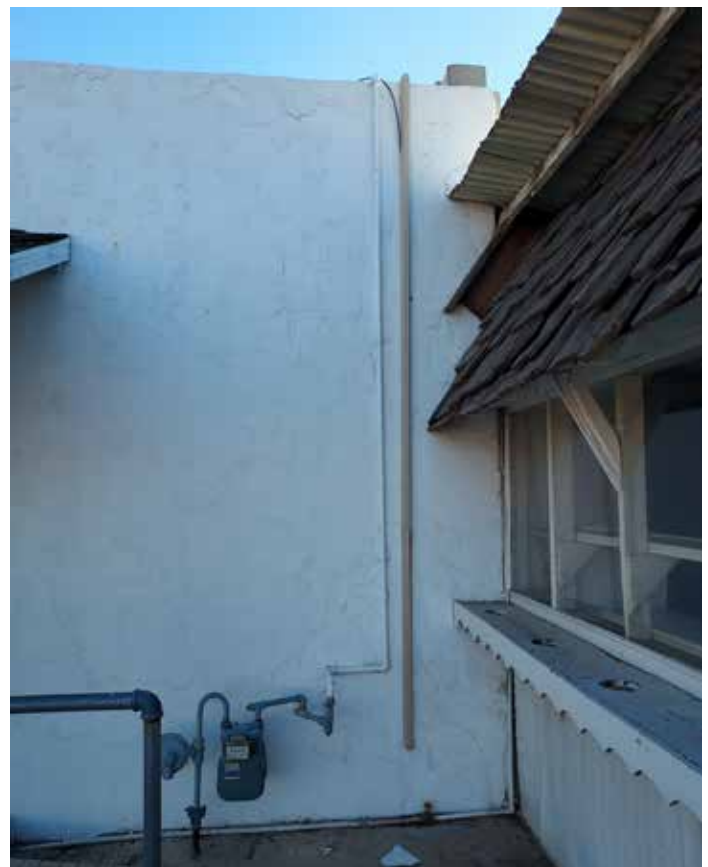
*Gas service*

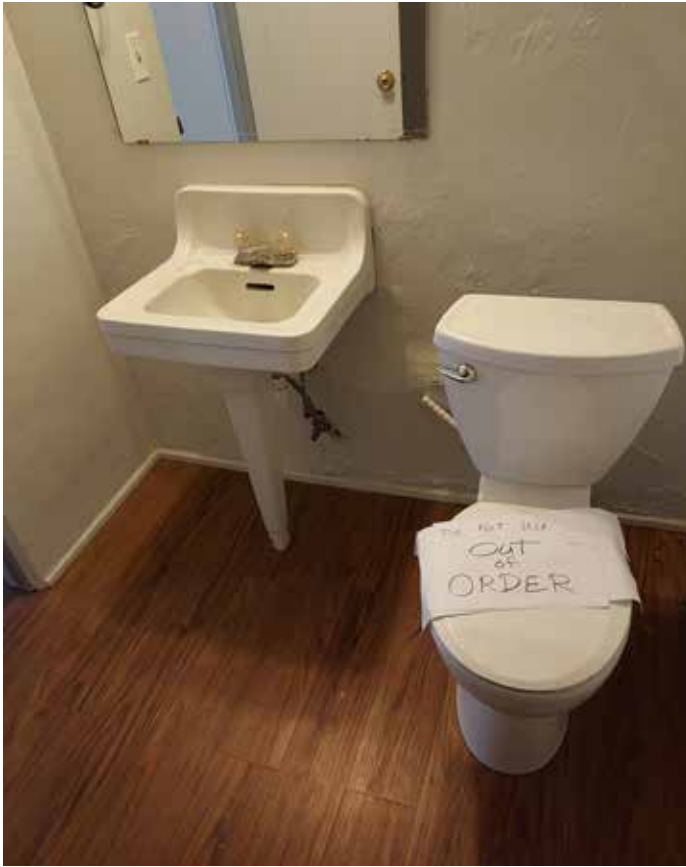
*Powder room fixture*

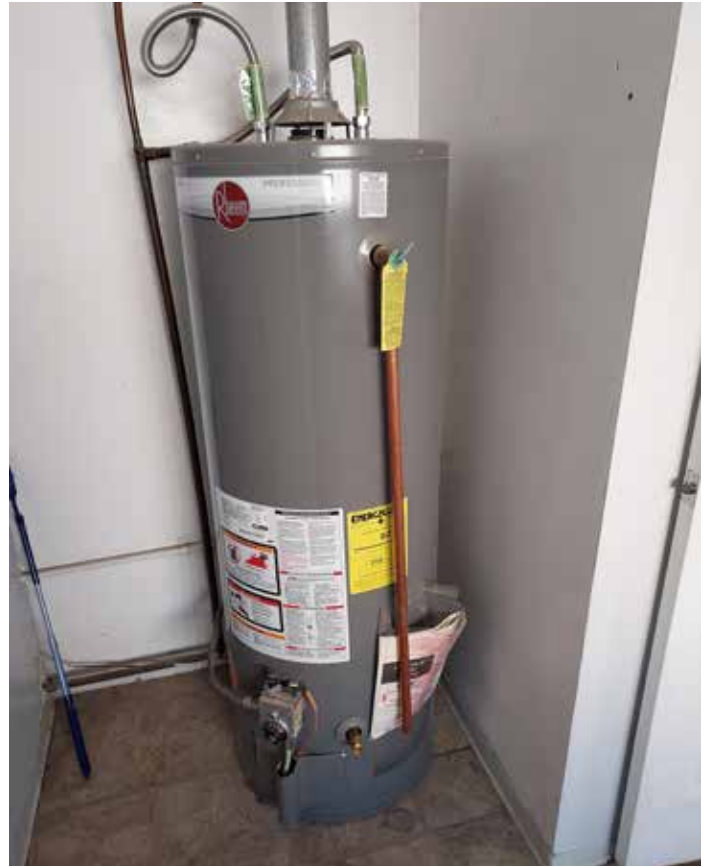
*Water heater*

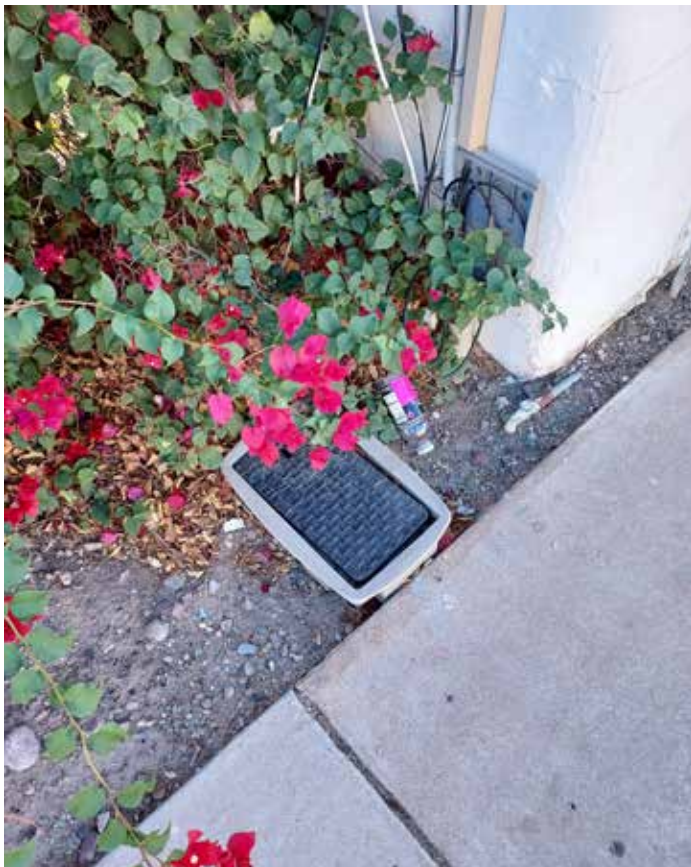
*Water meter*
