# **Watson's Flowers**

**A Building Condition and  
Needs Assessment of**

# Watson's Flowers

Project No. 23-012  
December 20, 2023

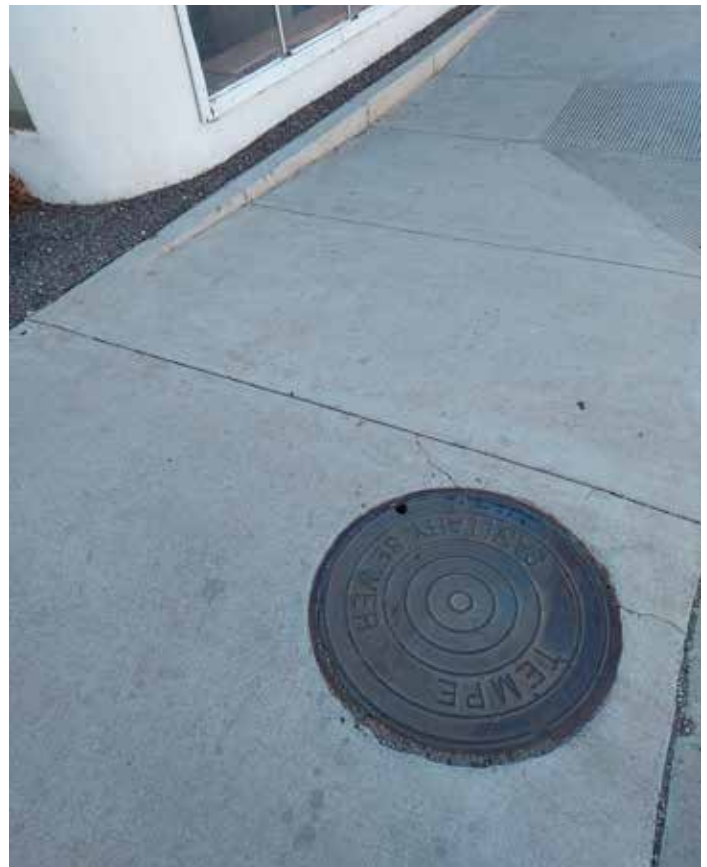
*Sewer manhole*

Piping systems should be more closely evaluated by an engineer or contractor to determine their age and condition, if they are to be reused. Plumbing fixtures may be reused or replaced, as needed, for a future rehabilitation.

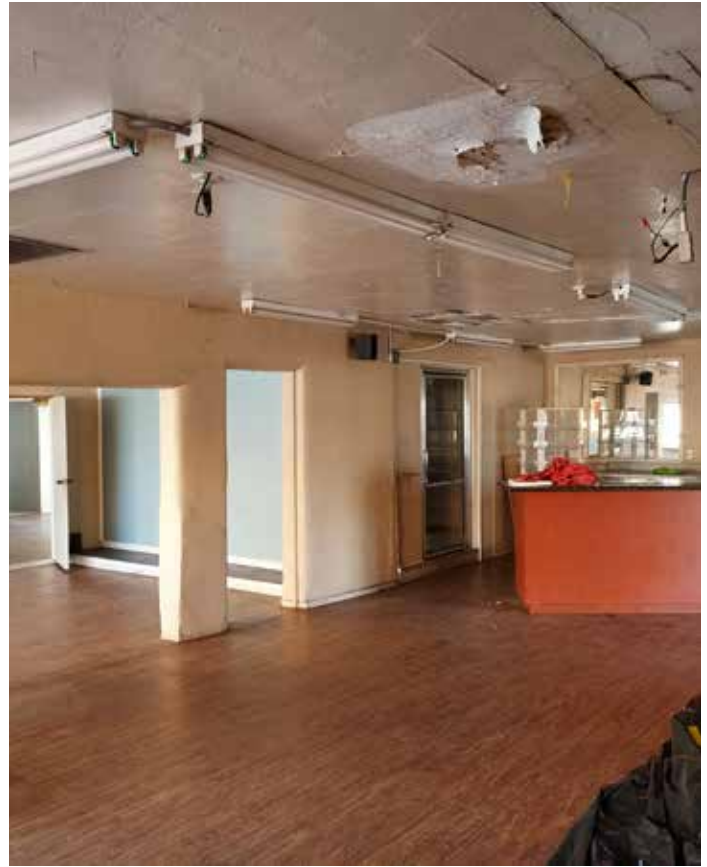
*Existing light fixtures*

Lighting fixtures should generally be replaced with architecturally compatible modern fixtures.

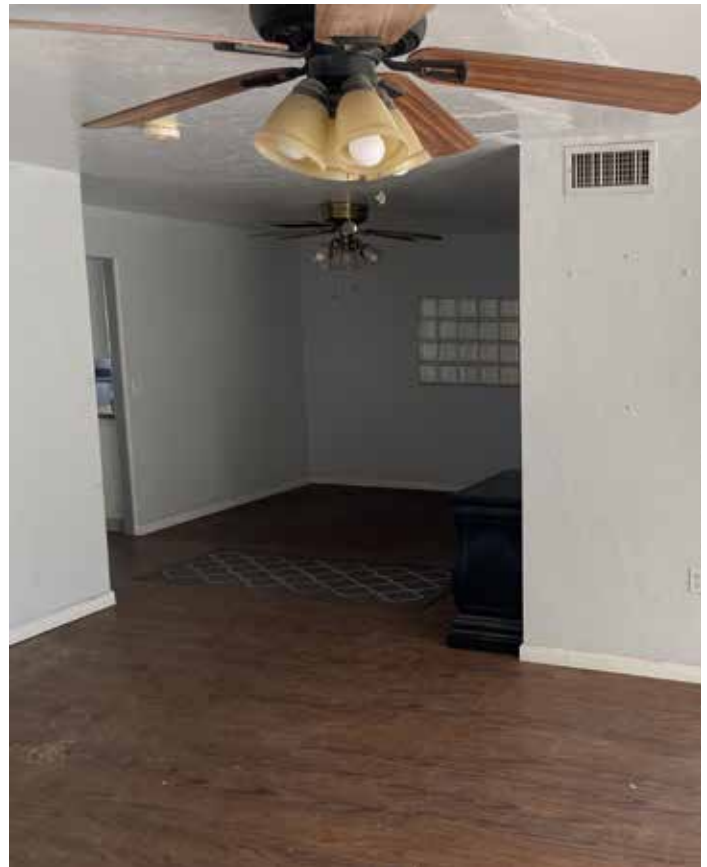
*Existing light fixtures*

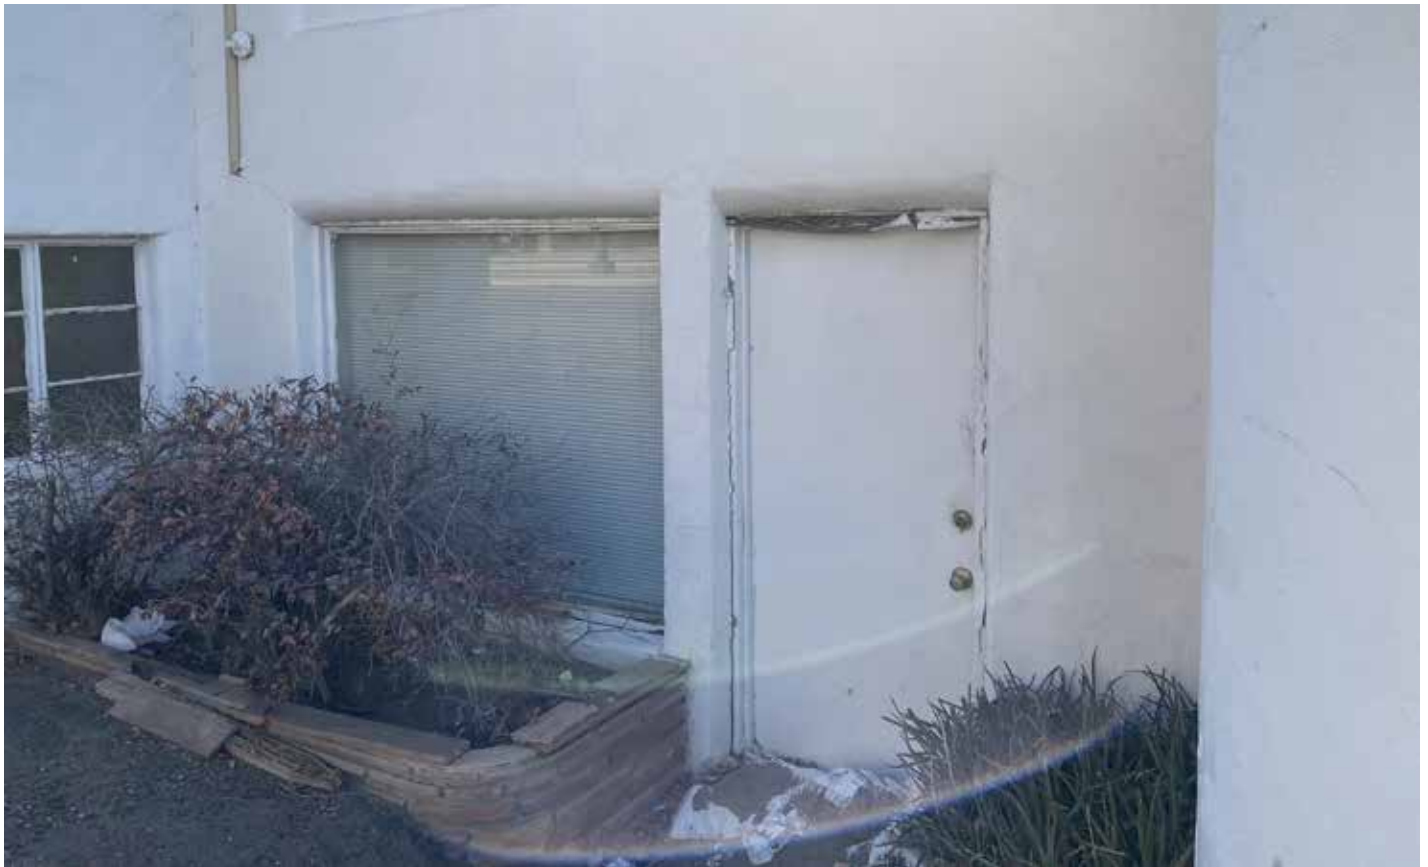
North Entry

The north entry area retains water and even channels it into the entry door in this location. The grade transition down to this door is not achieved in a safe way to be traversed by the public. The building is essentially built to the right-of-way line on the north and it would not be possible to achieve a proper drainage condition using surface drainage only, without affecting grading within the Apache Blvd. right-of-way.

Provide a catch basin and piped drainage out of the north entry area. Depending on the availability and depth of a storm drain nearby, it may be possible to connect to it. Otherwise, drain piping will need to run west in the R.O.W. to daylight or to future retention or drywell, if planned as part of a new development. Remove sloped backfill from the sidewalk and replace with steps. Ensure that the outfall at the catch basin is significantly lower than the door threshold.

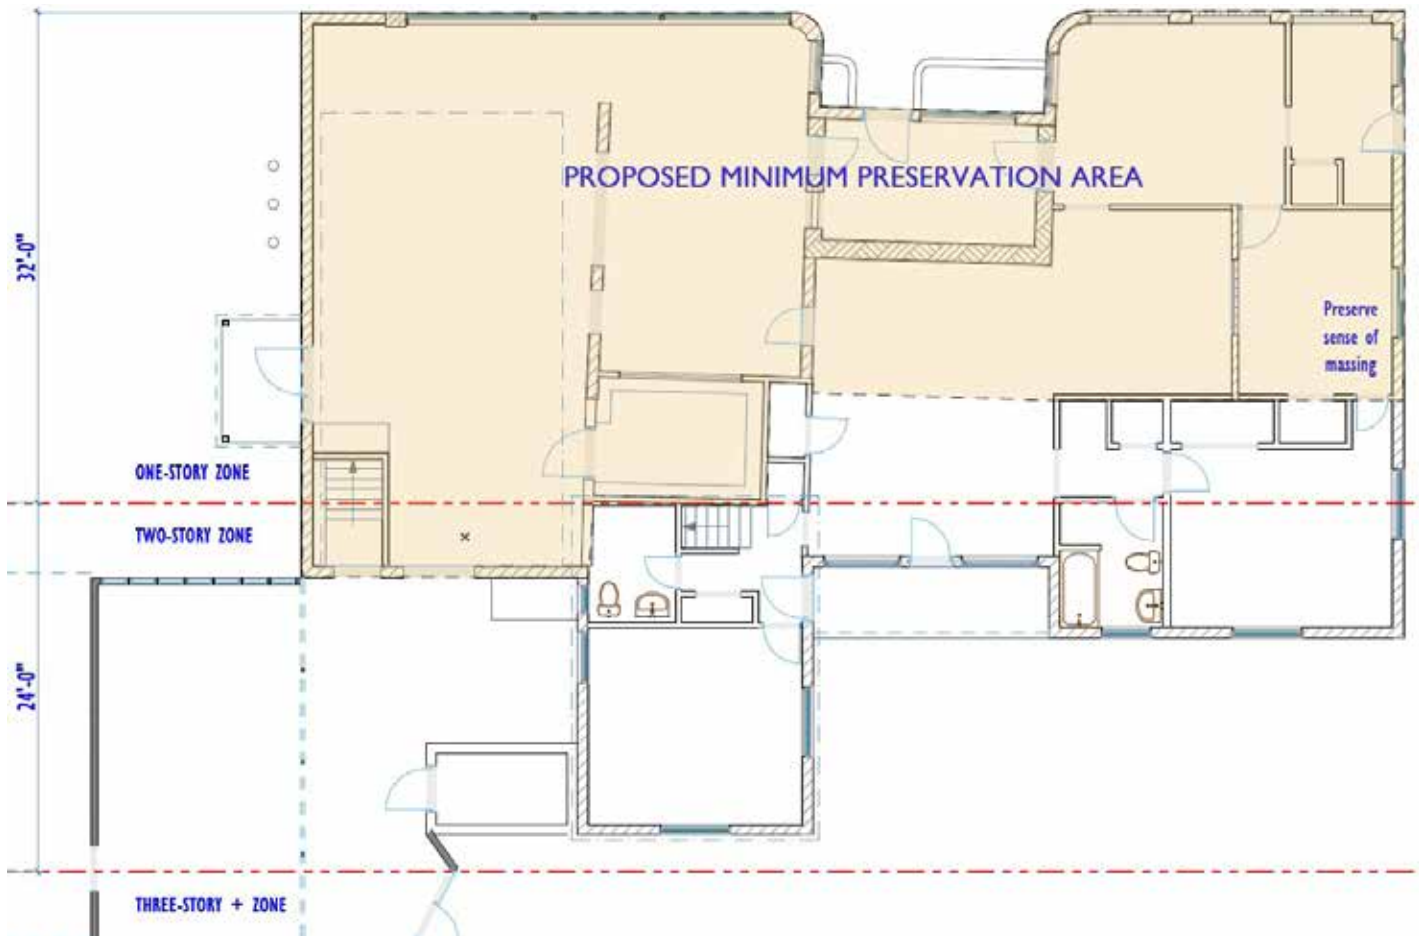
illustrates the building area containing the Character-Defining Elements, and this area is recommended for preservation.

In our opinion, with preservation of the indicated area, the building would retain adequate integrity to continue to qualify for historic listing. This implies that if the non-shaded areas are lost or altered, integrity would not be compromised past the point of eligibility. However, additional considerations must be taken into account regarding the impact made by new development on the building's setting and its visibility. First of all, the location of any new buildings or additions should not obstruct the view of the remaining west, north and eastern historic building facades from the street. Maintaining reasonable open view corridors as indicated in the following graphic should accomplish this goal. Secondly, new construction should be respectful of the historic building's scale. It has been shown that the 2-story section of the 1953 addition, while visible from the street, does not appreciably impact the appearance of the 1-story parts of the building. Therefore, two-
