HAYDEN BUTTE AND PAPAGO PRESERVES MANAGEMENT PLAN

November 13, 2024

Working Draft

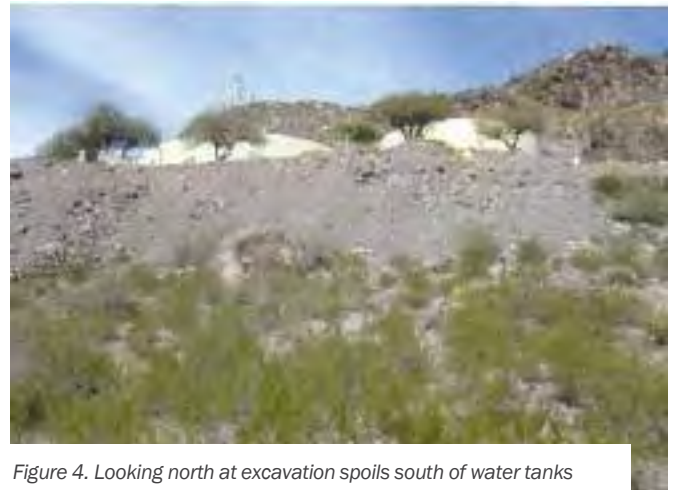
Figure 4. Looking north at excavation spoils south of water tanks

Portions of the original landscape at Hayden Butte have been altered by human activity. The most significant alteration is the result of bedrock excavation to construct the water tanks on the south face of Hayden Butte. The excavation burden was placed over the existing slopes to create the building pad for the tanks as shown in Figure 4. Other minor areas of man-made fill placement occur where hiking trails have been constructed (predominantly on the south and west faces of Hayden Butte). Historically, mineral prospecting may have occurred on the north face of Hayden Butte causing minor alterations to the landscape, but these impacts are hardly noticeable.

As noted previously, it was assumed in the 2017 study conducted for the Hayden Butte Preserve that the excavated material (the rock and dirt from excavation) was placed over the natural slope south of the tanks during construction. To allay any concerns about the stability of the dumped talus/rock, the safety factor for the built slopes was modeled and analyzed by Terracon as part of the 2017 study. To further evaluate the potential rockfall hazard of the talus slope of the tank pad, in 2022, a field survey and mapping of hundreds of boulders on the slope and rockfall hazard analysis was conducted. The potential for rockfall is more likely to be caused by boulders having an average diameter of 18 inches, therefore they were the primary focus of the analysis. The evaluation attempted to establish whether potentially hazard-prone boulders could reach the pedestrian path on the southern flank of Tempe Butte or the Light Rail improvements.

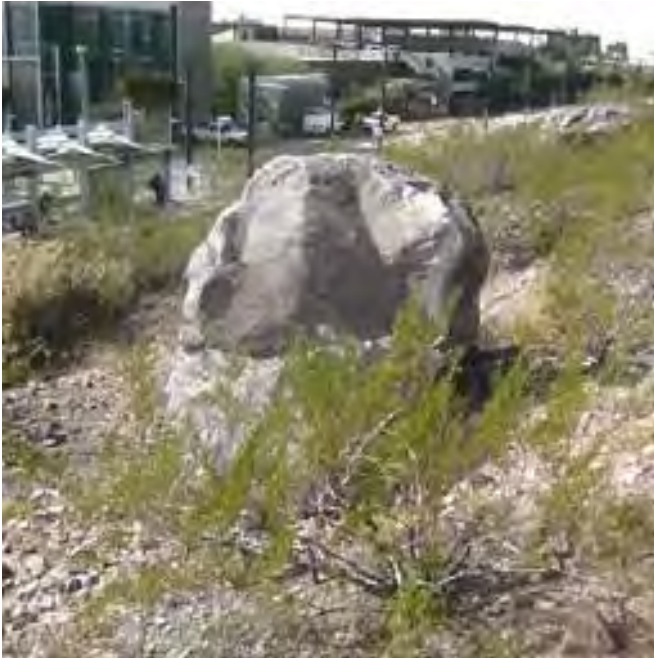
Figure 5. Colluvium boulder at the south flank of Hayden Butte

Geologic hazards are defined as conditions or phenomenon that present a risk or are a potential danger to life and property, either naturally occurring (e.g., earthquakes, volcanic eruptions) or man-made. The most significant geologic hazard on Tempe Butte is the potential rock-fall associated with rocks/boulders that become dislodged and travel uncontrolled down natural and man-made slopes and where bedrock is overhanging potential use areas. Figures 5 and 6 depict these conditions.

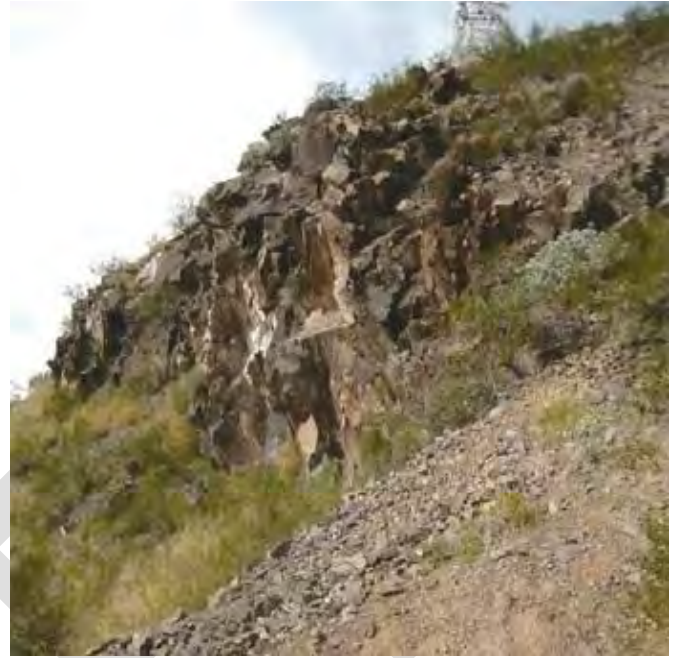
Figure 6. Overhanging bedrock

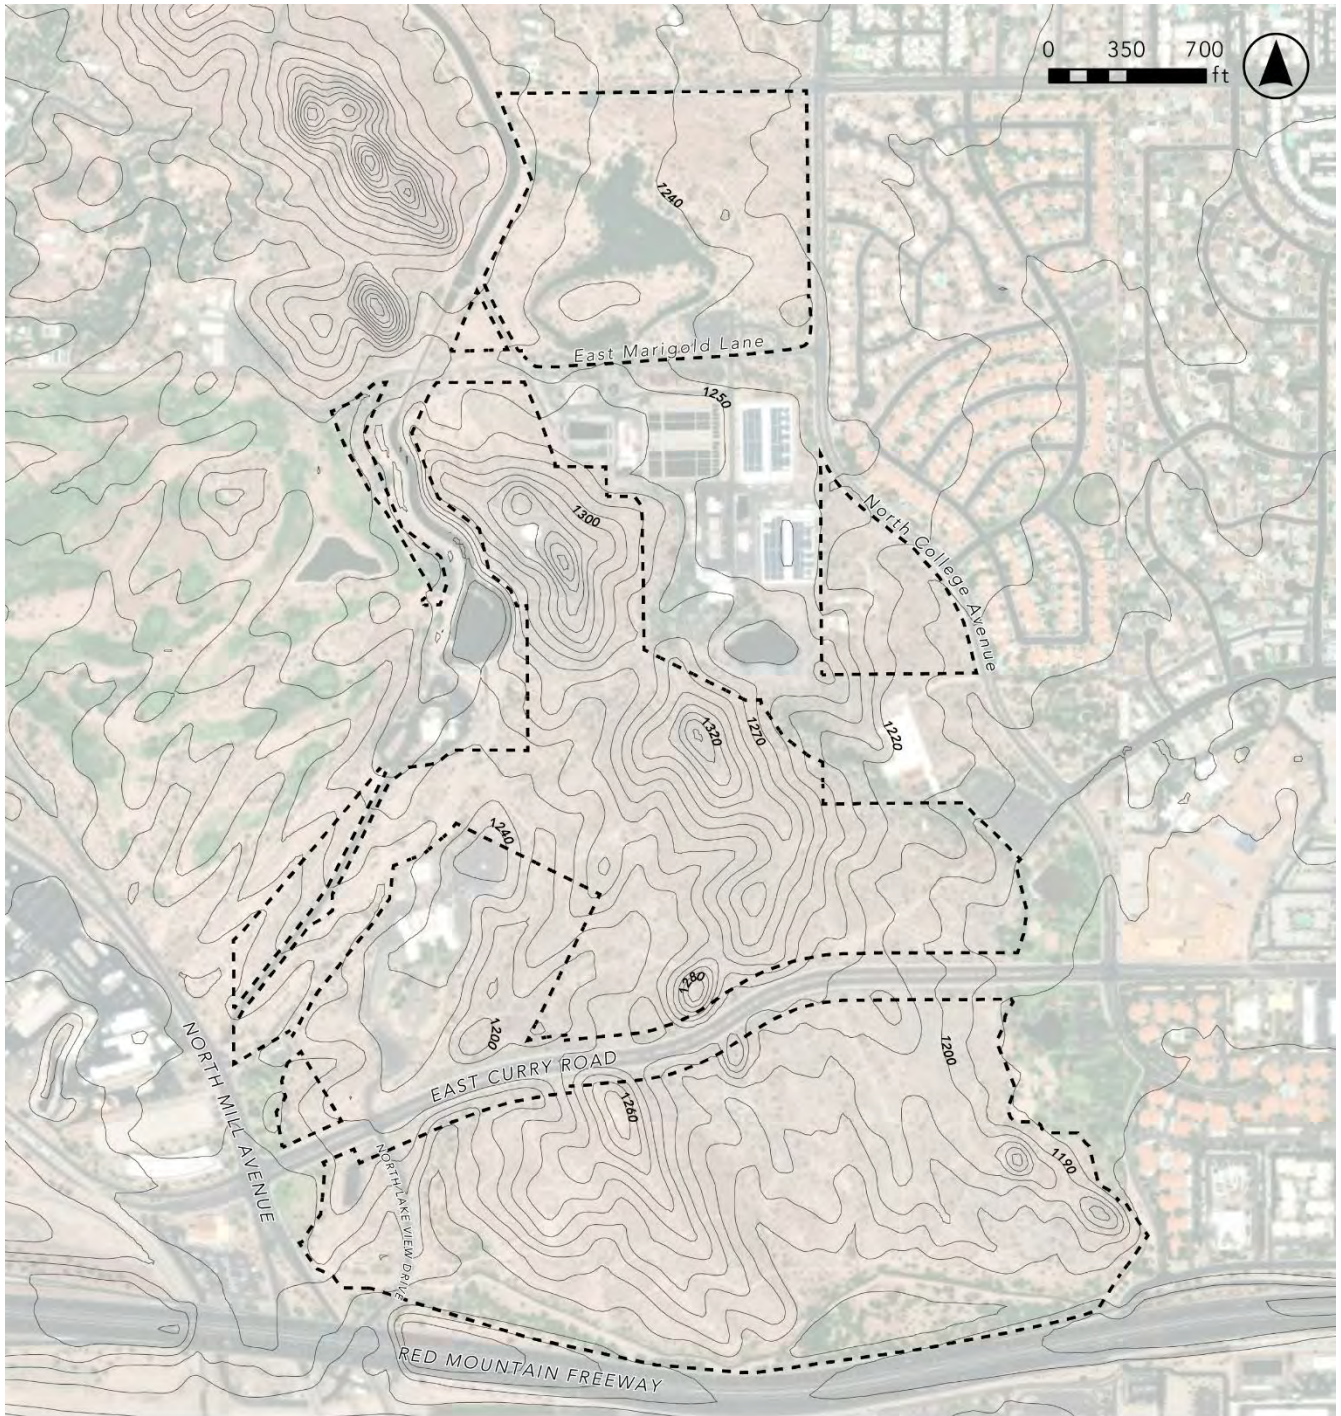
TOPOGRAPHY

Preserve Boundary - - -
 Contour Intervals 10ft
 Conservaton Sub Areas

Data Source: Created with 10m USGS DEM
